Type VIIC Free-Flooding Vent Patterns

Dougie Martindale
Accurate Model Parts

Part I - Introduction

Part II - Free-Flooding Vents

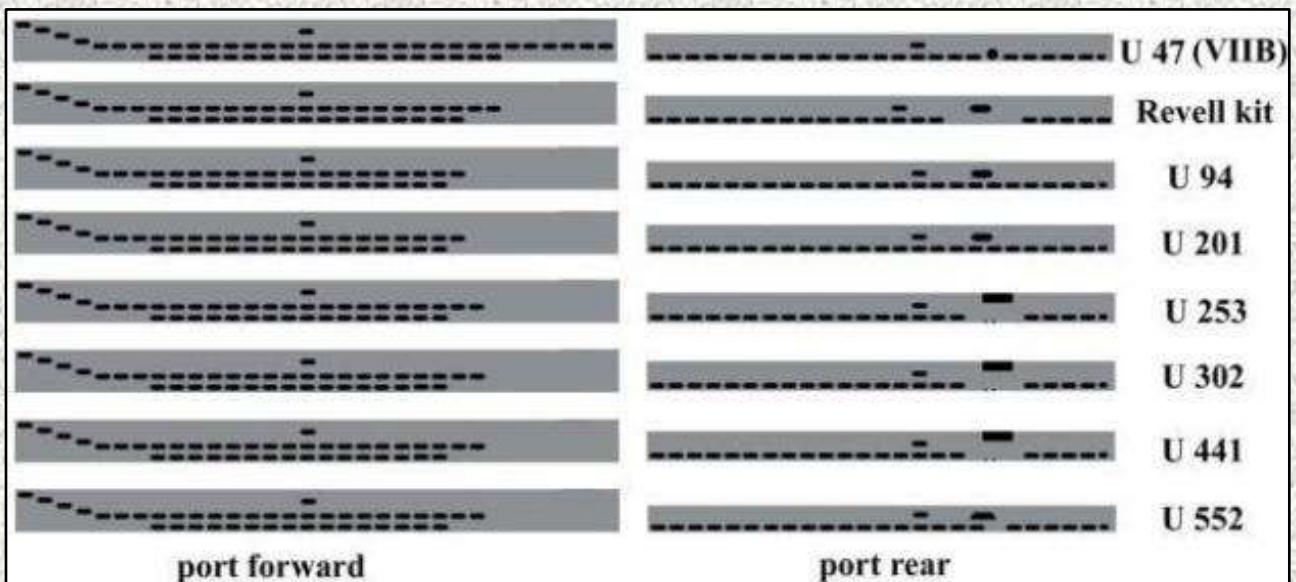
Above: The port side of the main groups of free-flooding vents for six VIICs, one VIIB and the Revell kit.

By comparing the Revell vent patterns with the VIIC vent patterns, it becomes obvious that alterations should be made to the kit. In fact, the main groups on the Revell kit are not accurate for **any** VIIC. In the main four vent groups alone, 11 vents need to be drilled, 7 filled and 2 altered if U 552 is being depicted. A similar number is required for U 94: 10 drilled, 8 filled and 2 altered. In my opinion, Revell should have included the maximum number of vents for each group so that no drilling would have been required. Although this pattern would not have been accurate for any particular boat, it would have been a simple matter to fill in the necessary vents for the chosen boat.

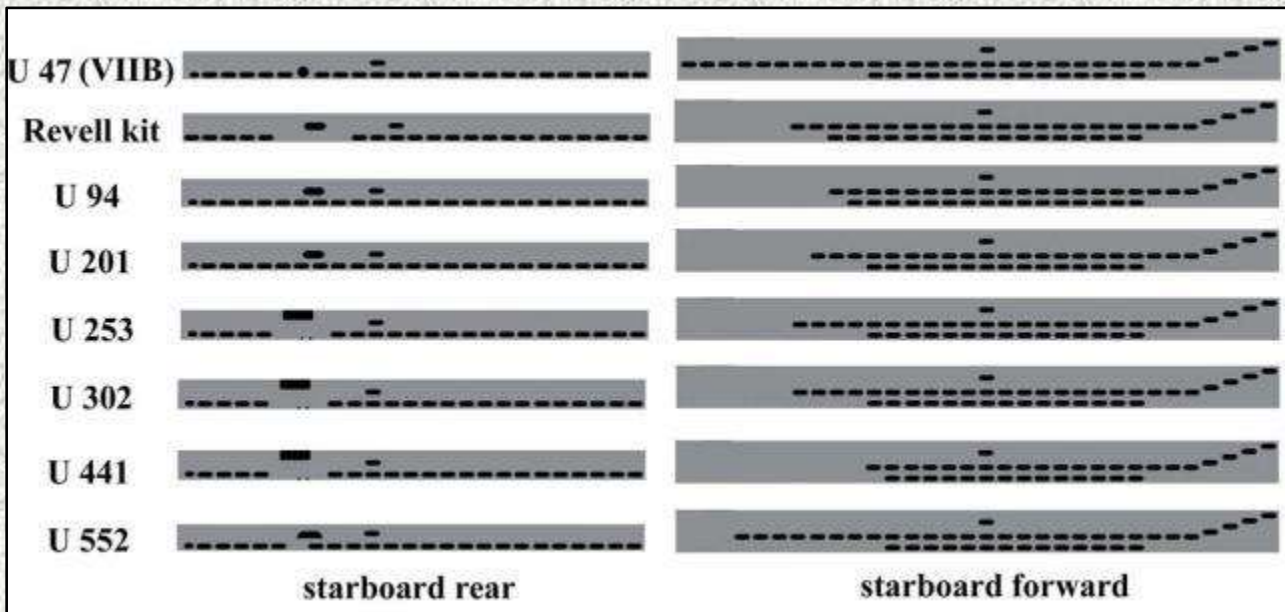
Note that even although U 94 and U 201 were both built at the *Friedrich Krupp Germaniawerft A.G.* shipyards in Kiel, there were still small differences in their vent patterns.

Above: The starboard side of the main groups of free-flooding vents. Wohlfarth's U 556 and Suhren's U 564 both had the same vent patterns as U 552.

In the image above, the vents located forward of the central drainage area on the starboard side of U 552 can be seen. The 25 vents on the top row of the starboard side extended farther aft towards the central drainage area than on many other VIICs. I have also seen these extra vents on the starboard side of U 132, U 331, U 564, U 565, U 566, U 570 and U 751. All these boats had the same number of vents on the lower row as U 552 (14 vents), except for U 373 (12 vents) and U 751 (16 vents). I have also seen these extra vents on the starboard side on two unidentified boats built at the *Kieler Howaltswerken* shipyards in Kiel. As U 392 did not have them, these extra vents were not present on all *Kieler Howaltswerken* boats. Since these extra vents featured on boats from several different shipyards, and these shipyards produced boats without the extra vents, we cannot, unfortunately, specify that they were particular to one shipyard.

It can be seen from the drawings that the VIIB U 47 had even more vents directly ahead of the central drainage area (28 vents on the top row). These extra vents, present on both starboard and port sides of all VIIBs, are a characteristic of the VIIB that can be used to identify a VIIB from a VIIC.

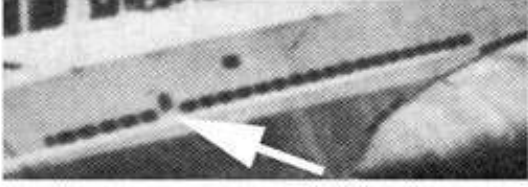
STYLE 1 VIIB only U 99 12th March 1940

Above (1a-1f): The holes pointed to with arrows are not free-flooding vents but one of the two diesel exhaust outlets. At least four styles of exhaust outlet can be seen in photos of VIICs.

The earliest style (which I have called style 1) was a circular outlet located along the line of vents in the main rear group. This style featured on the early VIIBs in the batches U 45 to U 55 and U 99 to U 102, but not on the VIIBs from other batches or any VIICs. These round outlets were modified on famous VIIBs such as U 47, U 48, U 99 and U 100 to the original VIIC oval outlet (style 2). Style 2, the style in the Revell kit, has a large oval hole above the line of vents.

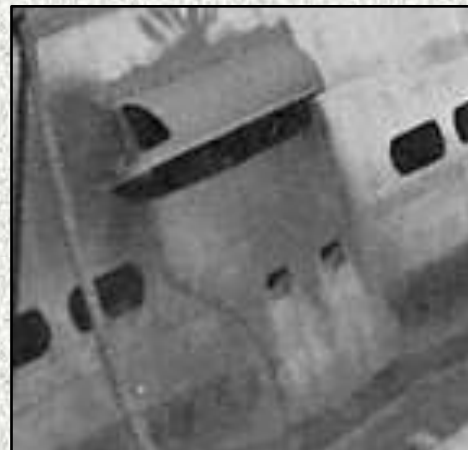
Above (2): There are always exceptions and peculiarities in regard to the Type VII. As pointed out by Bill Gordon, the Type VIIB U 73 had a different outlet when the boat served in La Spezia. This consisted of a shroud over the style 4 outlet.

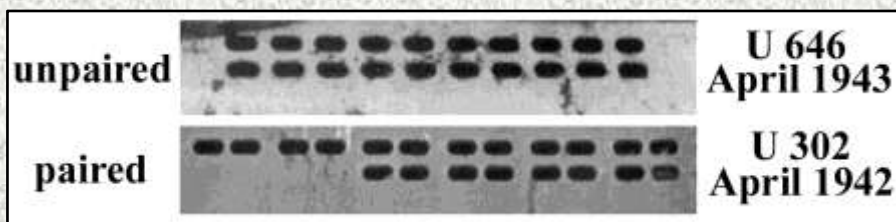
Left (3a & 3b): A comparison between paired and unpaired vent patterns.

It was commonplace for the medium-sized vents located above the large central drainage area (above the saddle tanks) in the early boats to have been arranged in pairs. The early VIIC style of paired vents was changed at some stage to a later style in which these medium-sized vents were evenly spaced apart (unpaired).

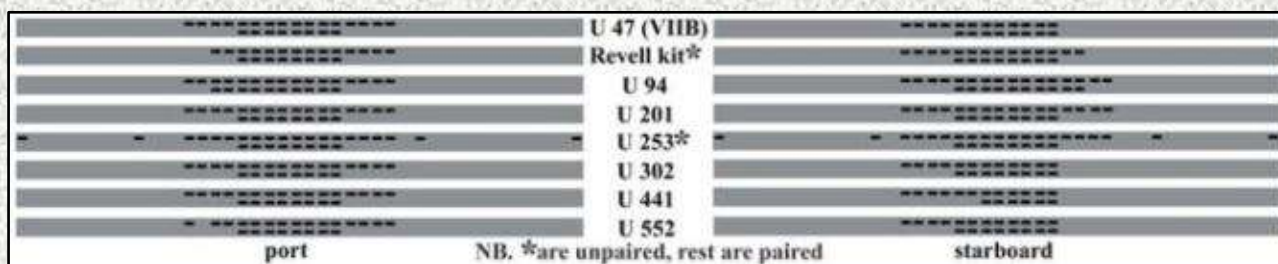
Above: The medium-sized vents above the central drainage area were rarely the same on port and starboard sides. There were usually fewer on the starboard side.

There were some boats which had 4 extra single medium-sized vents on the port side and 4 extra single medium-sized vents on the starboard side. The U-boats which sported this pattern include U-numbers 74, 80, 81, 82, 83, 132, 136, 202, 251, 253, 267, 269, 275 and 278. As all these boats were built in the *Bremer Vulkan-Vegesacker Werft* shipyard in Vegesack, this pattern appears to be particular to boats built in this shipyard. The medium-sized vents on the U-boats from Vegesack were evenly spaced apart (unpaired). This was unusual for U-boats built at the start of the war, since all the boats from other shipyards had these vents arranged in pairs.

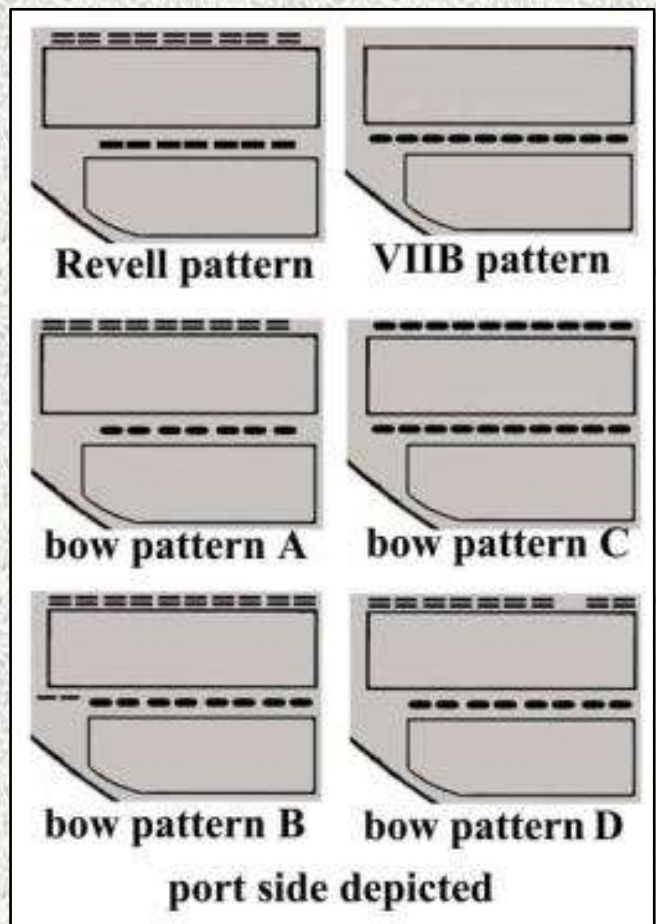
Above: This drawing illustrates the differences in the vent patterns near the port torpedo doors. The starboard vent patterns were the mirror image of the port vent patterns.

U 228 and U 1064 had the arrangement that I have called “bow pattern A.” This pattern had seven paired medium-sized vents between the doors and nine double rows of paired elongated vents above the upper doors. It is likely that all the boats which were built in the same batches as U 228 and U 1064 also had pattern A. Both of these boats were built at the *Friedrich Krupp Germaniawerft A.G.* shipyards in Kiel.

A higher percentage of U-boats had the arrangement that I have called “bow pattern B,” with eight paired medium-sized vents between the doors and ten double rows of paired elongated vents above the upper doors. The boats included U-numbers 69, 94, 333, 407, 441, 451, 458, 471, 551, 559 and 703. Some had the additional two elongated vents towards the stem, whereas some did not.

A much rarer pattern, bow pattern C, consisted of ten unpaired medium-sized vents between the doors and ten unpaired medium-sized vents above the upper doors. I have seen this pattern only once, in a photo of a VIIC dry-docked in Samalis in 1942.

Bow pattern D is also a rare pattern, which was found on U 929.

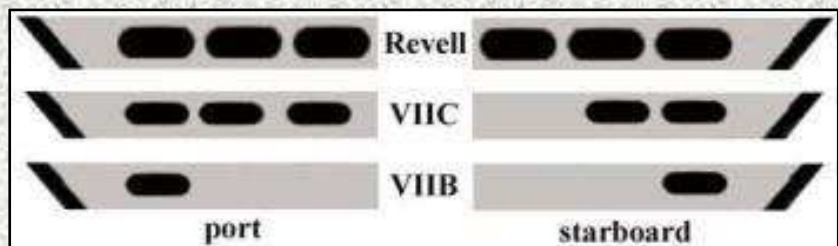
Right: The oval vents right next to the stem, above the level of the upper torpedo doors.

The medium-sized vents right next to the stem, above the level of the upper torpedo doors, are too large in size in the Revell kit. On the majority of VIICs there were three vents to port and two to starboard, rather than the three per side which feature on the Revell kit. Note also that the third vent from the stem on the port side was offset slightly from the second vent. Early Type VIIBs had only one vent next to the stem rather than the two/three that were present on VIICs. I have not seen any photos of late VIIBs in which this area of the hull casing is exposed, so I cannot say which pattern was present on the late VIIBs.

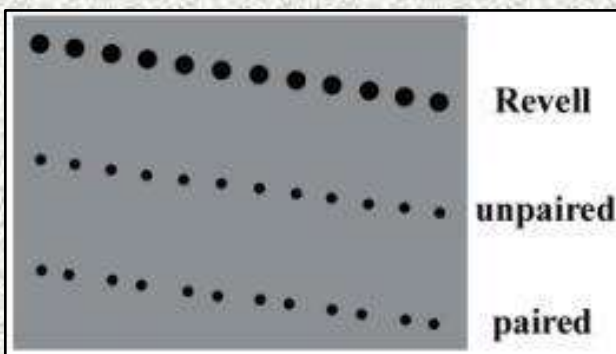
Left: The difference in diameter between the circular vents on VIICs and the large vents in the Revell kit is obvious.

One of the most noticeable inaccuracies in the Revell kit is that these twelve vents are **much** too large in the Revell kit. Since the line of vents is also too far forward in the Revell kit, it is easy enough to rectify both these problems: simply fill in the holes in the kit and drill new and smaller ones just aft of each of the filled holes.

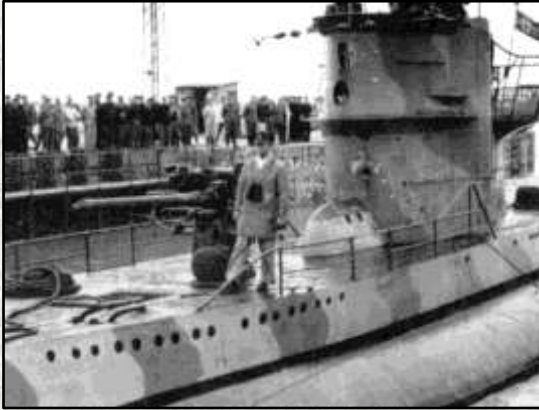
Left (4): The curved line of vents on the port side of U 82. Note that the 17 vents are arranged in pairs.

The breakwaters were replaced by a curved line of small circular vents of varying size. These vents allowed for a marginal improvement in diving times. Sometimes the vents in the curved line were evenly spaced (unpaired), as in the Revell kit, but more often the vents were arranged in pairs.

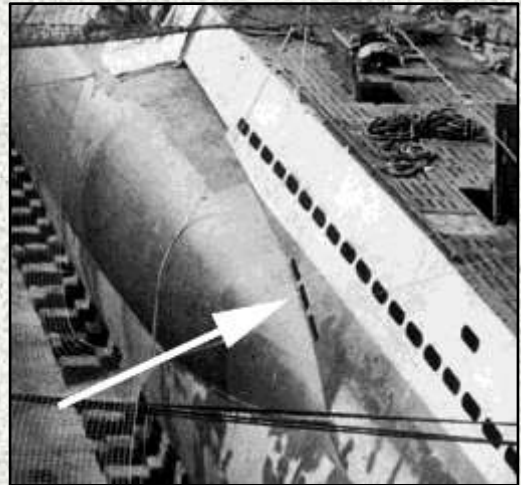
Right (5): The three vents immediately beside the saddle tanks were more elongated in shape than the main vents above.

The three elongated vents on the hull casing next to, and very slightly above, the rear of the saddle tanks are missing from the Revell kit.

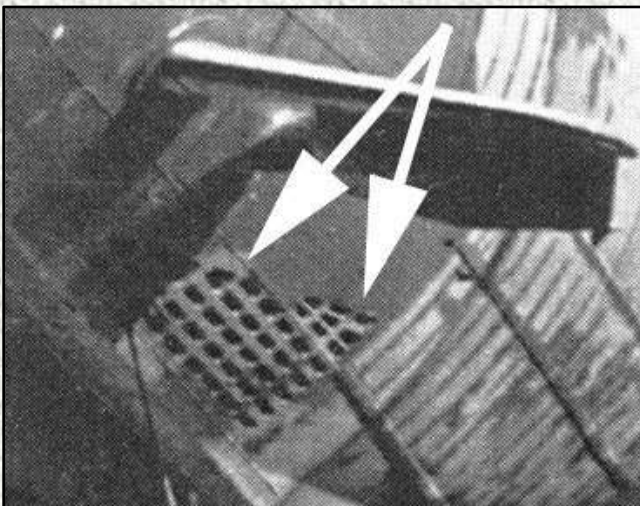
Above left (6): The right hand arrow on this photo of the VIIB U 99 points to a small group of vents that were present in some VIICs, but not in others. Above and forward of the vents are the port hydroplane and its guard.

There are very few clear photos in books of the pattern of vents behind the forward hydroplanes, nor are there side profiles or drawings which can be relied upon. What can be established from these few photos is that the pattern is a little too simplified in the Revell kit and, more importantly, the vents in the kit are rectangular when they should be oval in shape.

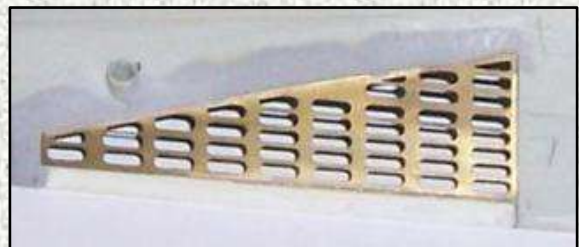
Above right (7): The area behind the forward hydroplanes can be greatly improved with the Modelbrass set, fitted to the author's model in this photo.

The photo-etched upgrade set from Modelbrass includes parts to replace this area of the Revell kit. The pattern in the set resembles the shape and pattern found in the museum VIIC/41 U 995. An extra group of 7 vents (slightly offset from the main group) were not a feature of U 995. This extra group needs to be filled in if U 995 were to be modelled. It is possible that all late U-boats did not have this extra group.

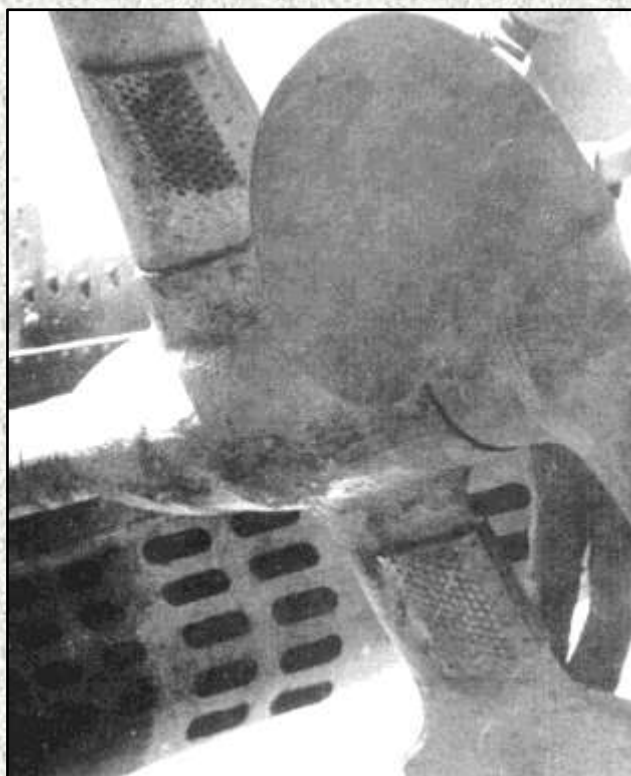
Left (8): By comparing this photo with the Revell kit, it becomes apparent that the vents in front of the port propeller were more numerous, and different in shape, to those in the model kit. The perforated plates may be sacrificial anodes (thanks to AMP forum member Pat).

Photos which show the pattern of small vents near the rear hydroplanes are even rarer than the group behind the forward hydroplanes. Due to the scarcity of photographic material, the pattern visible in photos of the museum VIIC/41 U-boat U 995 was used for the Modelbrass set.

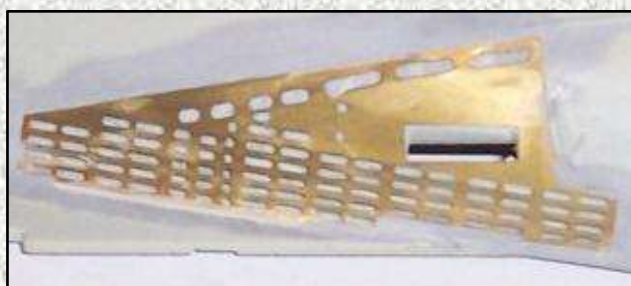
Below left (9): Although tricky to fit, the Modelbrass set greatly improves the pattern of vents behind the rear hydroplanes.

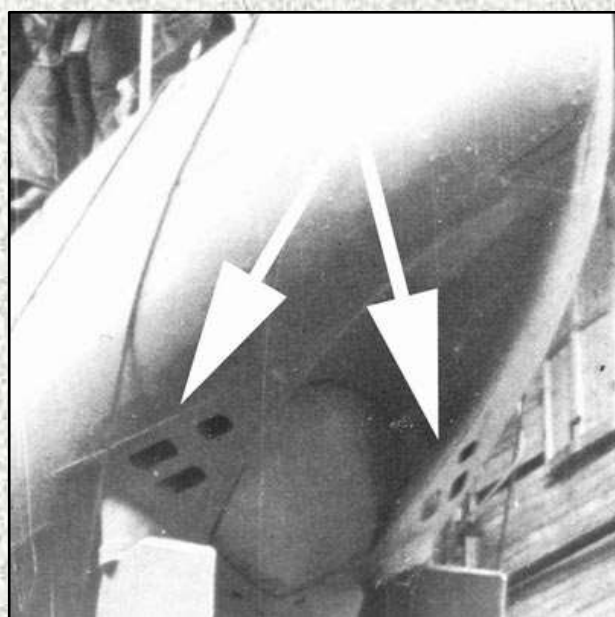
Right (10): Between the two sets of three vents is the aft torpedo door.

The two sets of three vents immediately aft of the rudders are reasonably accurate in the Revell kit.

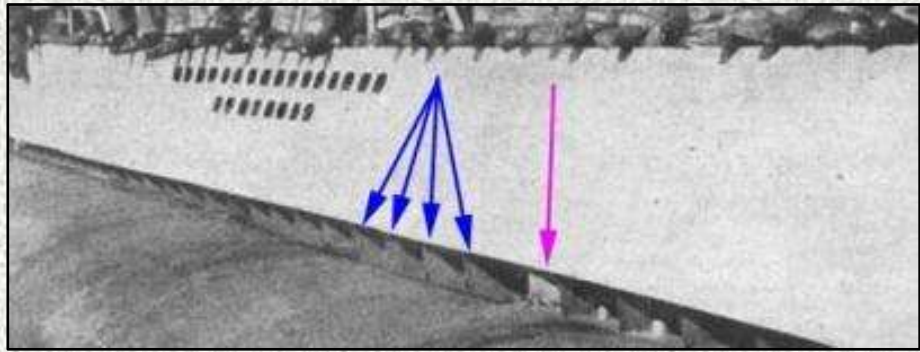
Above (11): The blue arrows point to the thin ribs while the magenta arrow points to one of the two thick round supports on either side.

U-boats had ribs which were spaced at regular 60cm intervals. These ribs could be seen in the central drainage area if viewed from a suitable angle. By adding vertical strips to represent these ribs, the hull casing above the central drainage area becomes much less prone to damage. In addition to the ribs were four thicker supports (two on each side).

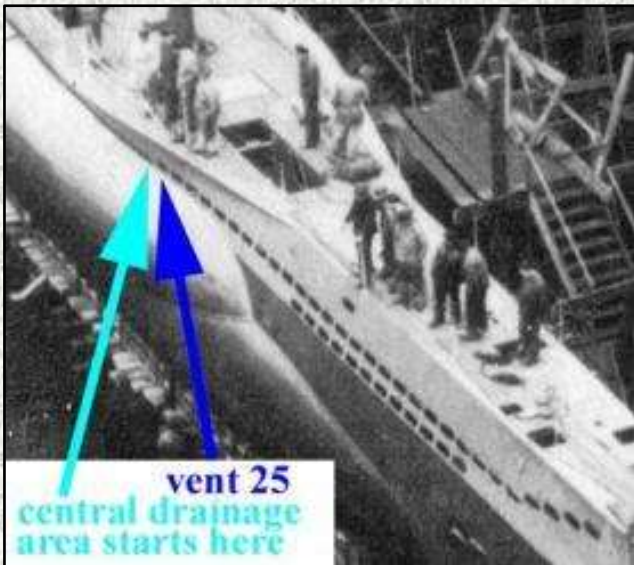
Above (13): Some VIICs such as U 373 above had 25 vents on the top row on the starboard side.

A number of VIICs had 25 vents on the top row on the starboard side. The central drainage area started directly behind vent 25, as can be seen above. In fact, the central area on the starboard side **always started at this same location**, regardless of the number of vents. On boats with 21 vents, if we count back to where the 25th vent would have been, the central area starts directly behind this point.

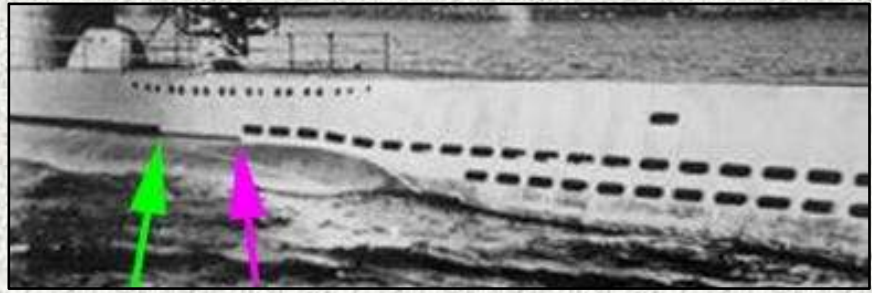
Above (14): This photo of U 331 shows that the main drainage slot on the starboard side started directly behind vent 25 (at the magenta arrow) but was very narrow in height for a distance. Farther back (at the green arrow) it widens out to be the normal height.

Another interesting aspect of the photo above regards vents 20 to 25. The top row from vents 1 to 19 are all in a neat straight line. But the five vents from 20 to 25 curve up slightly, and are slightly higher than the rest. This was likely done to keep an appropriate distance between vents 20 to 25 and the top of the saddle tank below. The crooked top row did occur on some other boats, while many others such as U 552 had a nice straight top row.

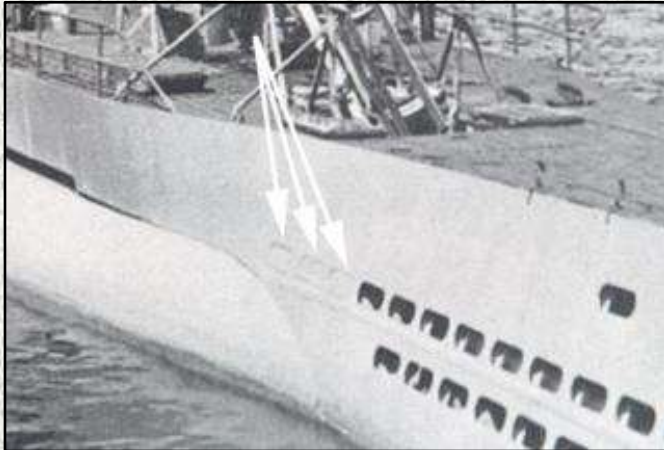
Left (15): The photo of U 441 shows that this boat also had a narrow slit at the front of the starboard drainage area. The photo also shows blanking plates behind three vents. This feature was not that common but can be found in some VIIC photos. The area this usually occurred was at the rear of the main set of vents on the starboard side.
