The Wolf Pack III

A Final Collection Of U-Boat Modelling Articles

Dougie Martindale
Accurate Model Parts

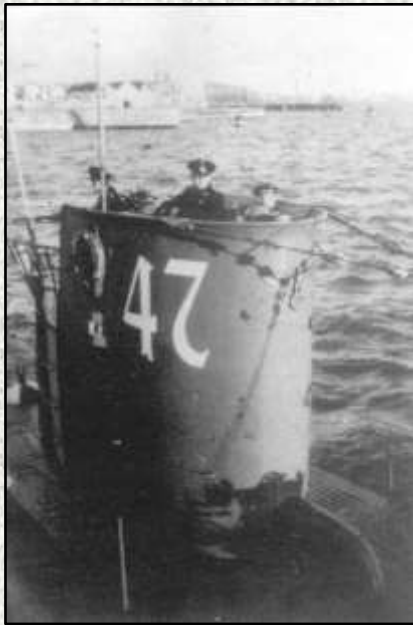
Left (A2): A number of pre-war features are evident in this photo of U 47 during her *Indienststellung* (commissioning ceremony) on the 17th December 1938. The paint is fresh since all U-boats received a fresh coat of paint for their commissioning ceremony. Note that there was no spray deflector midway up the front of the conning tower at this time.

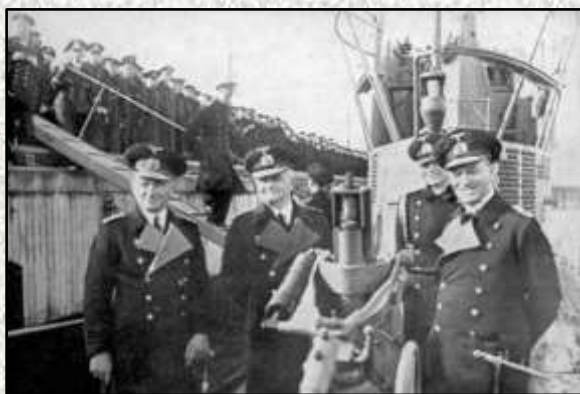
Left (A5): A comparison can be made between the tower railings and ventilation holes on either side of U 47's tower in this photo, taken at Wilhelmshaven on the 17th October 1939.

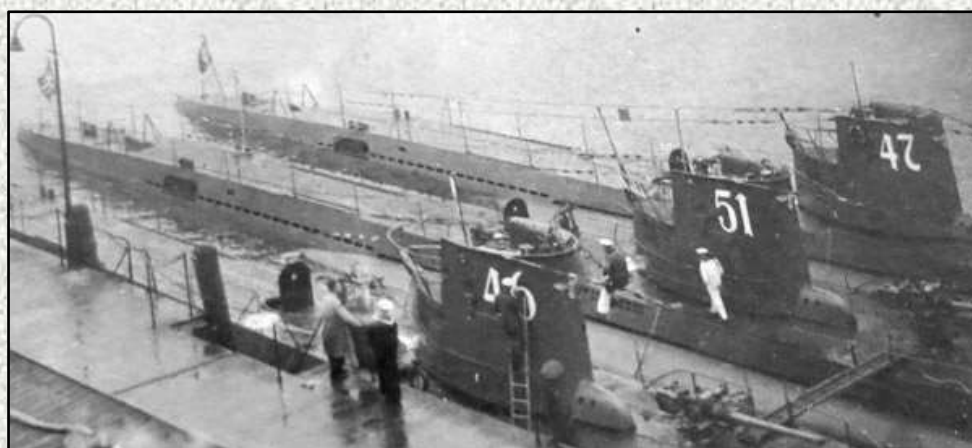
Below (A7): The three VIIBs look dark in this and a few other pre-war shots; it may be that the upper hull and tower of U 47 was a darker grey for a period during 1939. The dark patch surrounding the diesel exhaust outlet can be seen on U 47 and U 51. The dirty exhaust gases tended to blacken the paintwork around the outlet. During the pre-war period this area around the outlet was painted dark grey or black to disguise this weathering. By wartime this practice was generally discontinued.

During the pre-war period, the U-bootwaffe experimented with several paint colours on the upper hull and conning towers. In addition to *Dunkelgrau 51* - the most common of the Kriegsmarine paints - darker shades of grey were also used. The *Dunkelgrau 52* (RAL7024) paint was probably used on some U-boats. This darkish neutral grey was a little lighter than the dark grey *Schiffsbodenfarbe III Grau* used on the lower hull. Some of the pre-war shots of U 47 show a dark upper hull and conning tower. It may be that U 47 was painted for some pre-war periods in a grey that was darker than the standard *Dunkelgrau 51*.

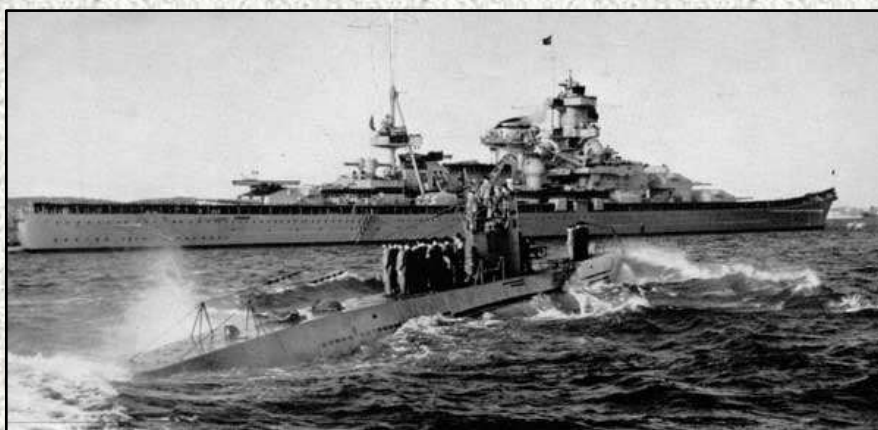
Below (A10): The famous photo of U 47 sailing in front of the *Scharnhorst*. The colour of U 47 looks very similar to the *Dunkelgrau 51* hull of the warship.

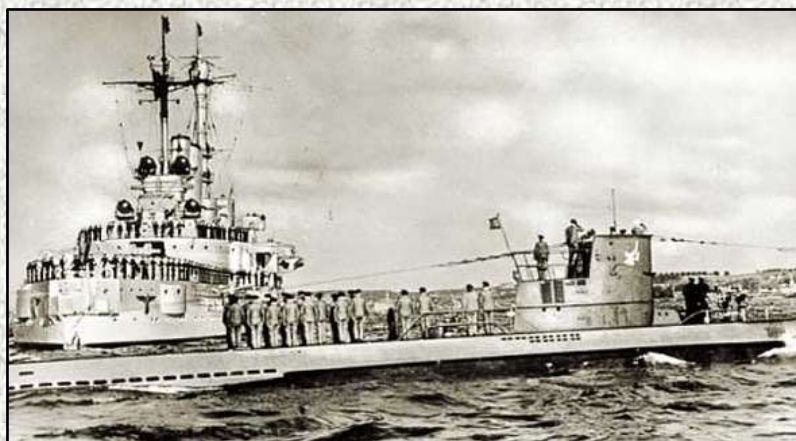
Left (A12): On the 23rd October, U 47 sailed past numerous battleships and cruisers moored in Kiel to celebrate the Scapa Flow mission. Crews of the *Scharnhorst*, *Emden* and the training ship *Schleswig-Holstein* paraded on deck in honour of the little U 47. This photo shows U 47 sailing past the training ship *Schleswig-Holstein*.

Right (A13): U 47 enters the *Germaniawerft* shipyards on the 24th October 1939. The patchy appearance of the tower is apparent. Note also that the mount for the 20mm Flak gun was on the aft deck at this stage.

Several photographs taken of U 47 between the 17th and the 24th October 1939 show that the U-boat's paint was far from fresh, and had sustained a reasonable degree of weathering. The starboard side of the conning tower had numerous patches of a darker paint where the rust had been treated and painted over. This may have been red lead undercoat, or a grey paint. In contrast, the port side of the conning tower was adorned with several patches of rust, and seems not to have been touched up with the darker paint. One might assume that both sides of the conning tower would have been treated at the same time, but apparently this had not been the case. There was also one large patch of a darker colour on the top of the starboard hull casing, just above the starboard saddle tank, which may also have been red lead undercoat or dark grey paint.

The area at the bottom of the U 47's tower, where the tower meets the deck, seems to have sustained a heavier rust build up than other areas. This was not uncommon, because water would drain down U-boats' towers and collect for a few seconds there before washing off the deck. In addition, the front of the towers often rusted quicker than the upper hulls because the front surfaces of the towers slapped against the water as U-boats ploughed through the seas.

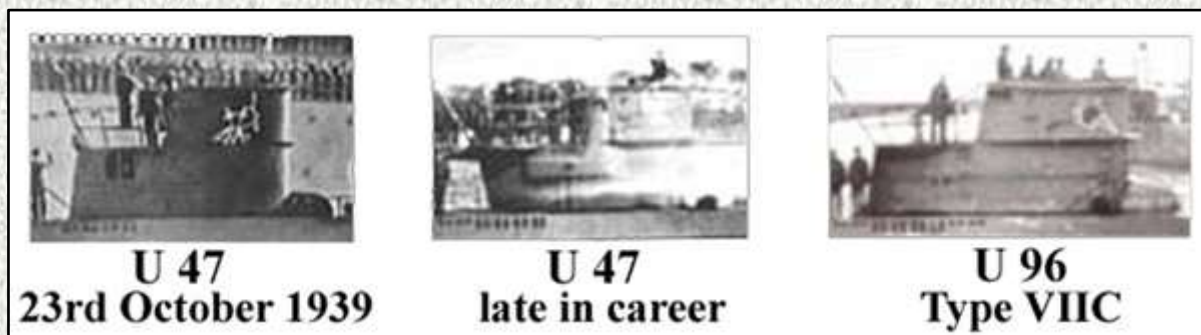
Above (A18): These images show how the angle of the trailing edge of U 47's conning tower changed in the December 1939 - February 1940 refit. Comparisons in this area can be made between U 47 on the 23rd October 1939, U 47 late in her career, and the famous Type VIIC U 96.

Since the rear of the tower was significantly larger than before, the rearmost vertical railing stanchion was located farther aft than it had been earlier. It was so much farther aft that the trailing edge of U 47's new tower sloped in the opposite direction than before. Also, the angle of the trailing edge of U 47's new tower was the opposite to the angle of the trailing edge of early VIIC towers. In fact, the angle of the trailing edge is one noticeable external difference that allows us to differentiate between a VIIB (with the 20mm on the rear of the tower) and a VIIC.

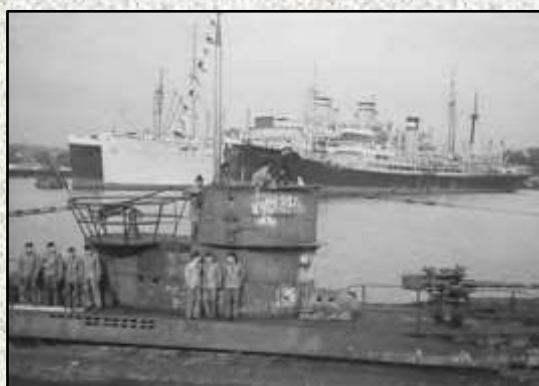
Above left (A19): Taken on the 6th July 1940, this image clearly shows U 47's modified tower, with the 20mm on the rear of the tower.

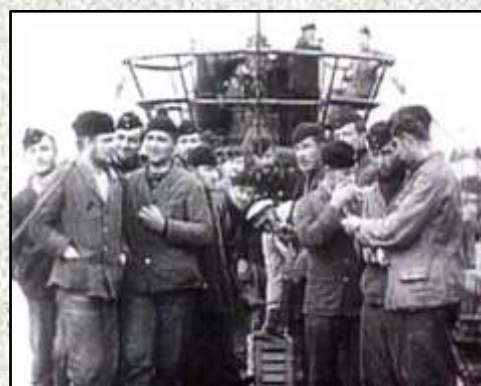
Above right (A20): Another 6th July image, this photo illustrates how the new tower railings protruded out much farther than the old style tower railings.

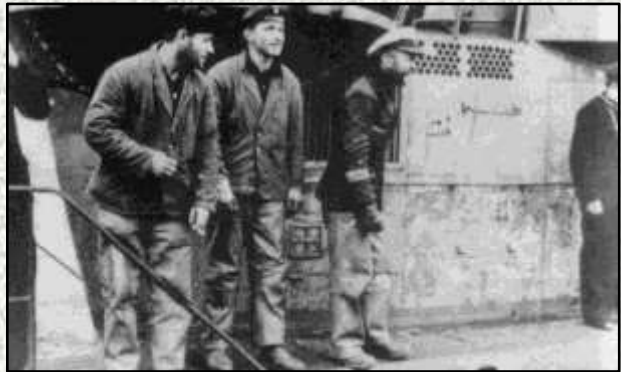
Right (A21): The grill with vertical bars can be seen behind the boat's laughing commander Prien in this 6th July 1940 photo.

A grill was added on the starboard side, beneath the front of the round area of the tower floor (D4). The addition of the 20mm to the tower resulted in some of the ventilation holes on the starboard side being blocked over, so a grill with vertical bars was chosen as a replacement for the

holes in this area. This allowed just as much, if not more, air to be accessed by the diesel intakes. A similar grill was **not** in place on the port side. On the port side, the addition of the 20mm to the tower reduced the number of circular intake holes.

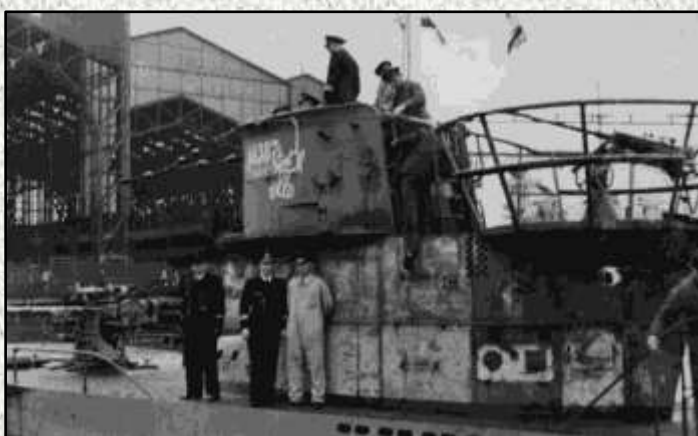
Above (A23): U 47 is about to enter the *Germaniawerft* shipyards in Kiel on the 8th July 1940. The heavy weathering is clearly evident in this photo.

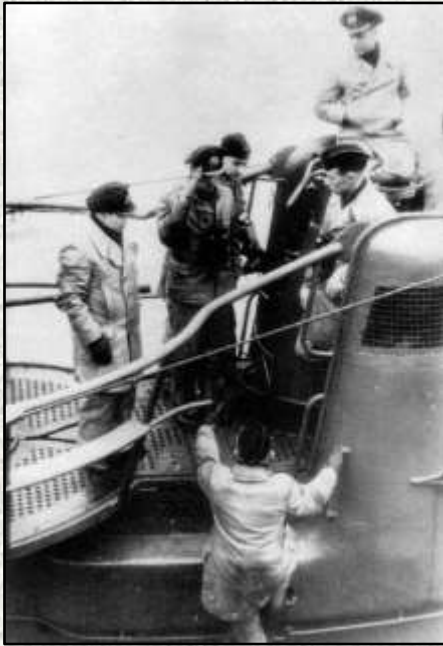
Above left (A26): The large air trunk on the starboard side (another was present on the port side) and the grill are apparent in this 3rd November 1940 image of U 47. The pattern of the square drainage holes on the floor of the tower are also noteworthy since they cannot usually be seen in most photos.

The most notable addition during this refit was the fitting of air trunks (H1). In original VIIs (also known as VIIAs) and VIIBs such as U 47, the supply of air to the diesel engines was poor. The main trunk providing air to the diesels was routed forward under the rear deck casing and up inside the after end of the tower. Ventilation holes to let air into the intake trunk were located on the after sides of the tower wall, primarily on the starboard side, and these were susceptible to interruption in high seas. To rectify this problem, during this refit large external L-shaped trunks were built up **both** sides of the tower, starting from the rear of the tower and extending up the after edge of the conning tower bulwarks.

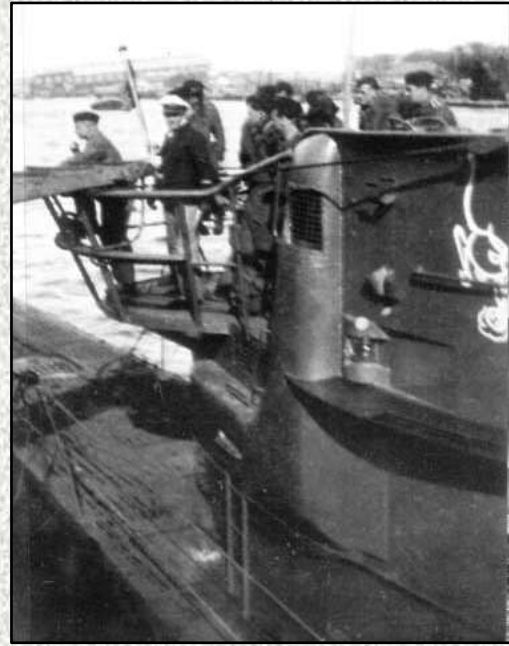
Above right (A27): The darker grey colour and the air trunking can be seen on U 47's conning tower in this photo. The spray deflector, being a horizontal surface, was painted black.

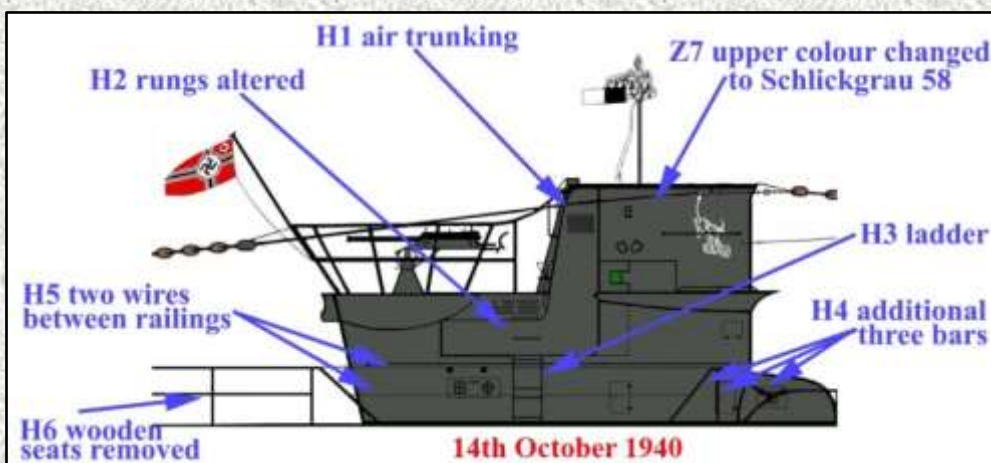
Below (A28): The tower of U 47 in late 1940, with air trunking on both sides and *Schlickgrau 58* paint.

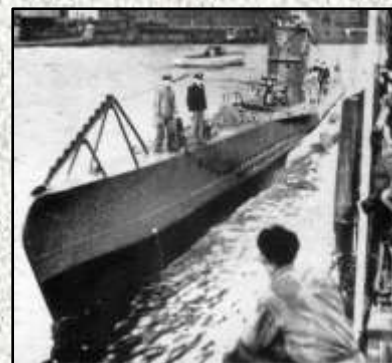
Right (A33): The front set of waterline draught numerals on the port side stand out in this late October 1939 photo of U 47.

Above right (A32): The six sets of white waterline draught markings were used on all Type VIIIs. The rear set was different from the other two sets.

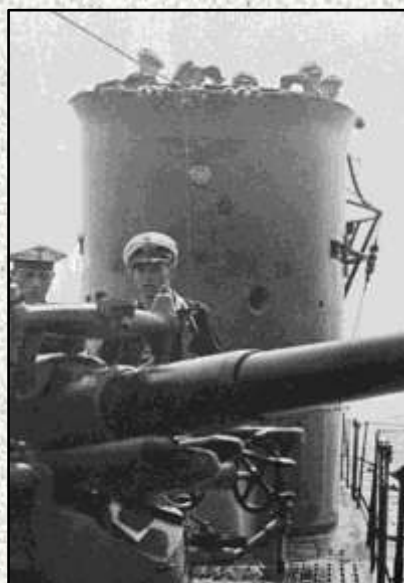
Right (B1): A pre-war Type IXA with no spray deflector, no wind deflector, a shallow curve to the top edge and bronze eagle plaque. The white pre-war number would have been on the side of the tower and is just out of shot.

Clearly the first four IXAs were commissioned with no spray deflector and no wind deflector. U 37 and U 41 (and perhaps others) were then fitted with a spray deflector prior to hostilities. Both boats did not have a wind deflector at this time, which is an indicator that the spray deflector preceded the wind deflector on these boats. On U 37 the combination of spray but no wind deflector continued into the earliest stages of the war. An exception can be found on U 43 which actually had both deflectors prior to the start of the war. Given the knowledge from other U-boat features, we know that features were often tested upon one or more boats before fleet-wide implementation. It would appear that U 43 was the boat chosen for the testing of both these features.

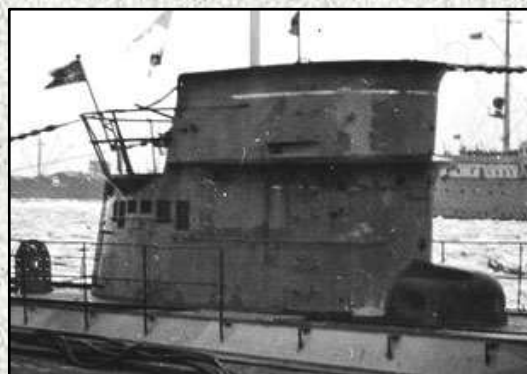
Above (B2): A full length spray deflector is in place on this wartime IXA but the top of the tower still does not yet have a wind deflector.

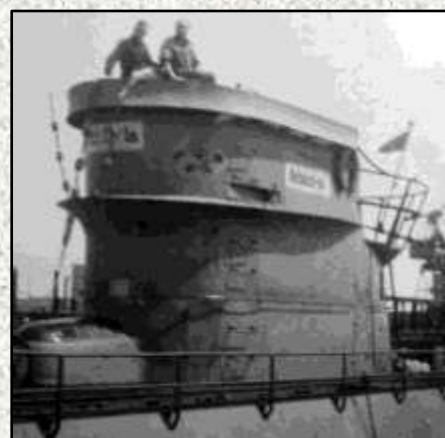
Above (B3): U 37 later in her career, with a full length wind deflector and full length spray deflector. The seven extra rungs can be seen in the very centre of this image.

IXA tower rungs - The IXAs originally had no tower rungs at all. On the port side there were only two horizontal railings and these were at the same level. There were two horizontal railings on the starboard side but the rear one was higher up. Early in the war, seven rungs were added to the towers of U 37, U 38 and U 39 ahead of the navigational light channels on each side; this consisted of three rungs added above the spray deflector and four added below the spray deflector per side. This feature was not added to U 43.

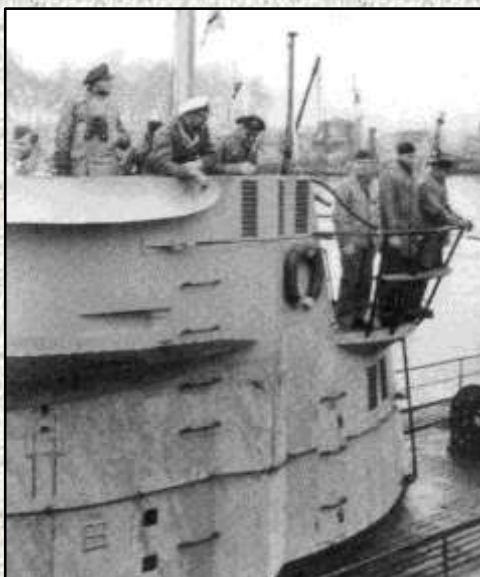
Above (B6): The port side of U 108 in December 1941, showing how style Y was separated into three sections due to the curved periscope rod aerial fairing. Note the feature towards the bottom left of this image; this includes a door with a square marker plus two square vents to allow water to drain in and out. This feature was present in some IXBs and all IXCs.

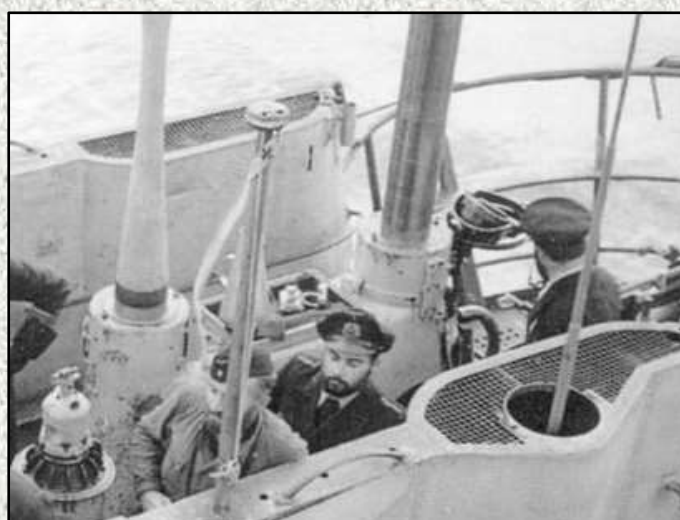
Above (B7): Style Z1 on U 129 in April 1942 clearly shows the criss-cross mesh grill and the periscope rod aerial in the raised position.

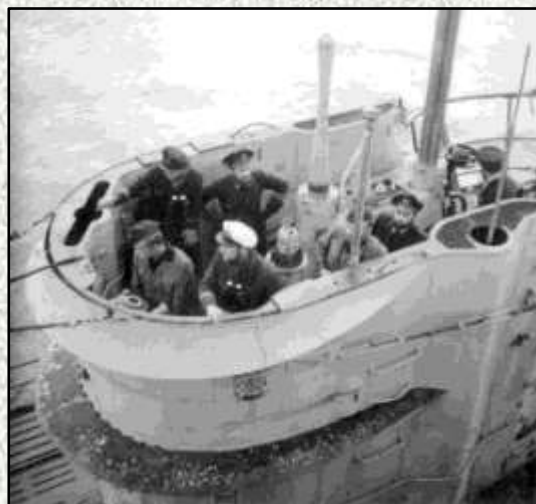
Above (B17): The windscreen can clearly be seen on U 160 in December 1942. The red arrow points to the windscreen base plate while the two blue arrows point to the angle between the three sections. We can see that on U 160 the screens were present in three directions: a double screen at the starboard side, a triple screen in the middle and a single screen on the port side.

The style of the windscreens varied depending on the shape of the base plate. Some screens were longer than others, while others employed more clear sections than others. It would appear these were effectively hand made with no standardisation between all boats. As can be seen from photo 17, U 160 had a base plate which had a single screen on the port side, a triple screen in the middle, and a double screen at the starboard side. The IXBs tended to only have single screens. In the middle there was typically a double-length screen on the left and a single-length screen on the right; this was in addition to a single-length screen on the port side. Sometimes a single screen was fitted to the starboard side while on other occasions it was missing. U 108 was completely different in that this boat had a curved base plate which differed from the typical base plate arrangement. In some cases the frame did not extend to the top whereas on boats such as U 160 the frame was full height. The IXC U 509 was different from other boats in having a triangular shape at the forward port corner of the tower, with a lip which ran around the edge.

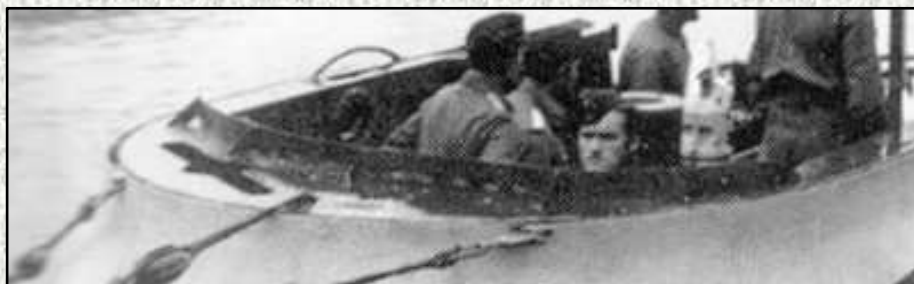
Left (B18): The additional wind deflector shield on U 68 in April 1942.

As an alternative to the clear windscreen, a few boats including U 68, U 128 and U 502 had metal sections added permanently in place around the rear of the base plate. These did not appear to be removable and had triangular support plates ahead of the sections. Removable clear screens could have fitted into these sections but this is speculative and there is no evidence of this being in place in period photographs. Instead this feature appears to be simply an additional wind / wave deflector shield that crewmen could hide under. The height was low meaning that any benefit would be marginal. U 172 also had a flange but this was a very narrow height.

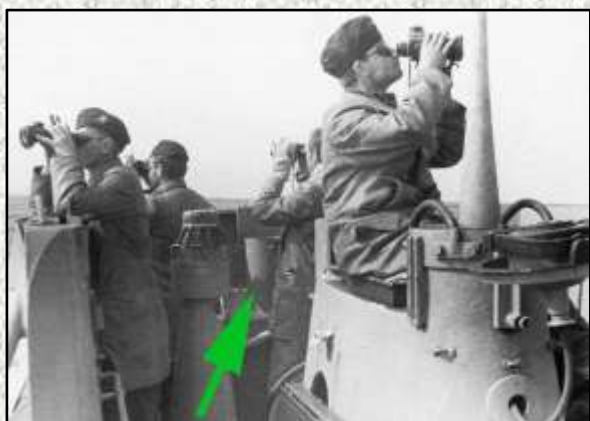
Left (B22): An early photo of U 124 before the windscreen baseplate was added. The green arrow points to the position of the vertical tube housing the third periscope. Note the foldable step at side of the periscope housing and the extended periscope at the rear having no anti-vibration wires; these features point to an early time period after being commissioned in June 1940.

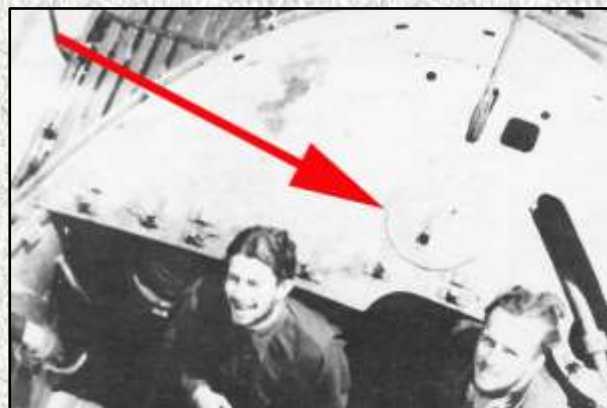
Below (B23): The red arrow shows the lid of the circular cover which is present within the windscreen baseplate on the IXA U 43. The third periscope would extend upwards through the circular gap when this cover was removed. Incidentally, the raised parts at the rear of the baseplate allowed the windscreen frames to be held in place when they were intended to be utilised.

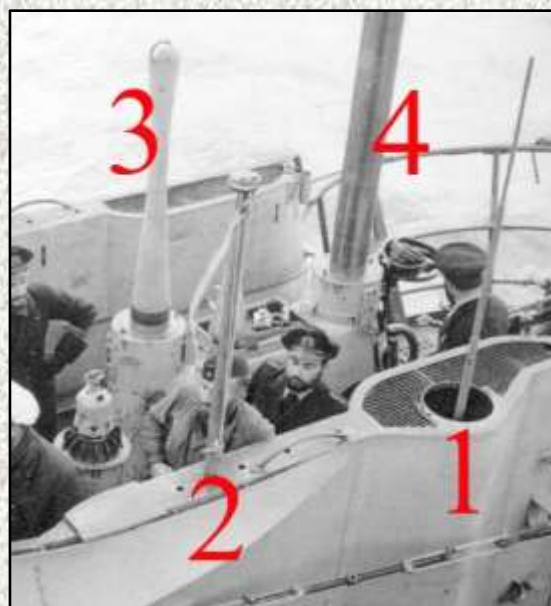
Above: (B24): U 129 in April 1942 shows various features discussed in this section: extendable rod aerial (1); commander's flagstaff (2); sky periscope head (3); attack periscope shaft (4). Note how the extendable rod aerial has various thicknesses which progressively reduce as we advance in height. The modeller would need to use three separate rods of different diameter which fit into each other. This would require careful sourcing of rod as there is very little difference in diameter in 1/72nd scale. Note also that the tower bulwark on the starboard side is presently devoid of wooden panelling.

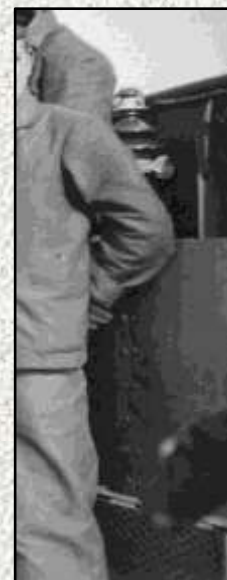
Above (B26): The area on the inside of the starboard bulwark in a pre-war photo of the IXA U 40. Note how the top has a shelf with object.

Area on rear of starboard bulwark - There was a feature that was in place when all the IXAs and earliest IXBs (U 64, U 65, U 122, U 123 and U 124) were launched. On these boats there was an area at the top of the inside of the starboard bulwark consisting of a shelf and an object which bears some resemblance to an early version of the UZO. U 123 had this feature in May 1940 but it had been removed by September 1940, suggesting that its removal occurred in the summer of 1940. Originally these early boats had no air intake (style W) but this was replaced with air intake style X. It may be that the change to the style X air intake precipitated this change.

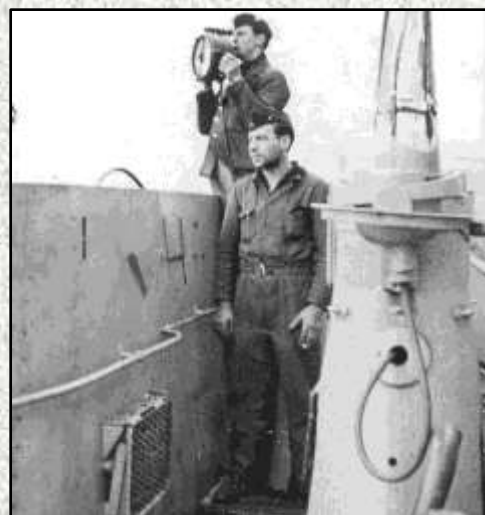
Right (B27): The inside of the port bulwark of U 108 in 1940 shows an absence of wooden panelling. There is a foldable metal seat on the bulwark and the side of the periscope housing. Note the anti-vibration wires on the attack periscope which suggest an early application to U 108.

Foldable metal seats - The IXAs and the earliest IXBs (U 64, U 65, U 122, U 123 and U 124) had four foldable metal seats on the bulwark sides: two on the starboard bulwark and two on the port bulwark. The rearmost seat on each bulwark was lower and slightly longer. Each rectangular seat was normally in the vertical position and folded out to the horizontal position due to a hinge at the top. The top surface of each seat had a criss-cross pattern which might reduce the likelihood of a foot slipping. Each seat was thick and sturdy enough to support a crewman standing on the criss-cross surface when the seat was folded outwards. Despite their practical benefits these metal seats were all removed in 1940. The reasons for the removal may be that they were bulky and protruded several inches in from the tower bulwark, reducing ease of access for crewmen passing between the bulwark and periscope housing. Furthermore, despite the corners being rounded to reduce potential injury, a hapless crewman could easily bash their shin or knee against the thick steel seats in heavy seas. One assumes this error would be rather painful.

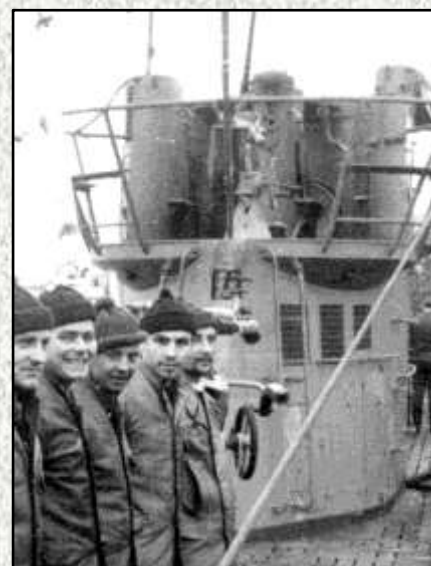
Above (B28): This later shot of U 108 shows that the metal seats have been replaced by a ledge low down on the bulwarks and on each side of the periscope housing.

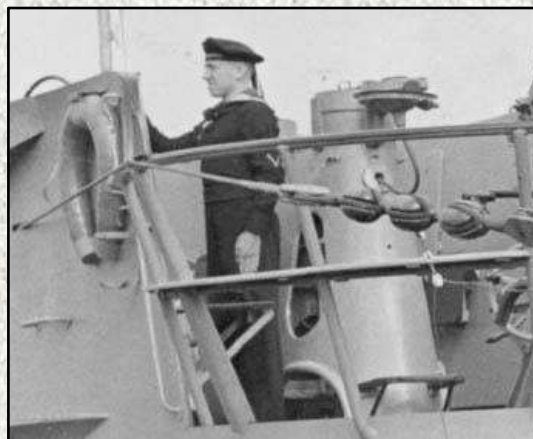
Above (B31): The commissioning of U 103 in July 1940. The semi-circular drainage gap at the bottom of the periscope housing can clearly be seen along with a substantial rim at the edges. The C-shaped ring and two support bars below can be seen at the bottom of the rear end of the periscope housing.

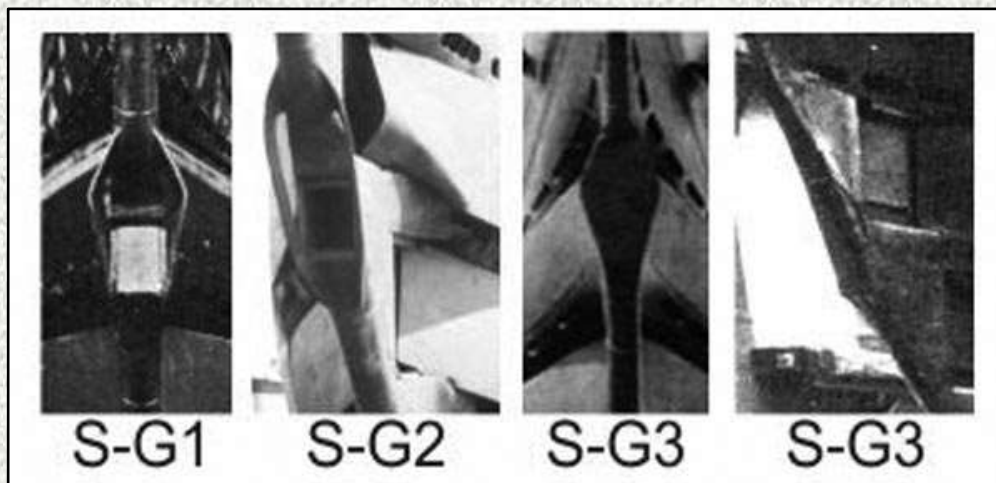
Above (B35a-B35d): The three styles of S-Gerät on the stem of early to mid-war IXCs. There are two views of S-G3. The frontal view of S-G3 is U 158 and the side view is of U 194.

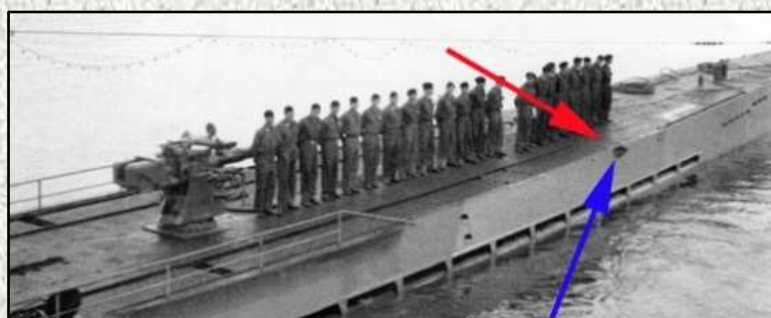
Above (B40): U 106 in position 2, with the blue and red arrows showing very little separation between the fairlead and bollards.

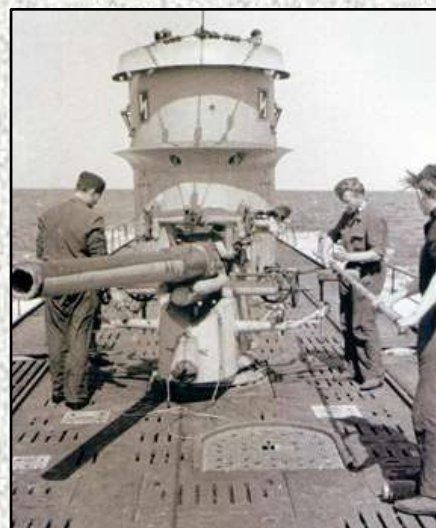
Above (B42): The access hatch is clearly offset to port ahead of the 105mm deck gun.

Offset to port - Some IXBs, IXC's and IXD's had the hatch just ahead of the 105mm deck gun but slightly offset to port; these included U 66, U 67, U 68, U 103, U 124, U 126, U 128, U 129, U 154, U 155, U 156 and U 163.

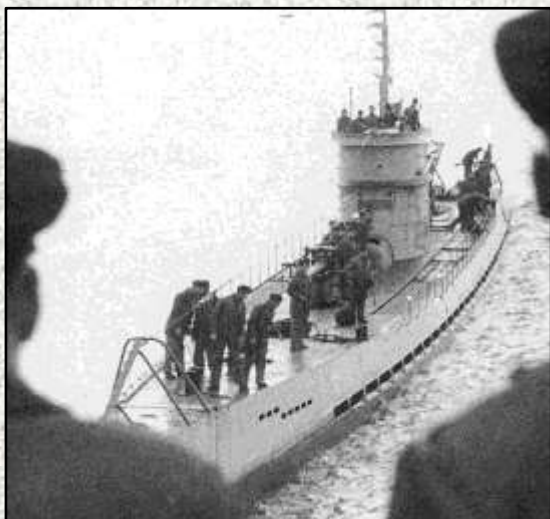
Above left (B43): The upper net cutter on this wartime shot of the Type IXA U 37 has ten serrated edges rather than the nine edges on Revell's early war IXC kit.

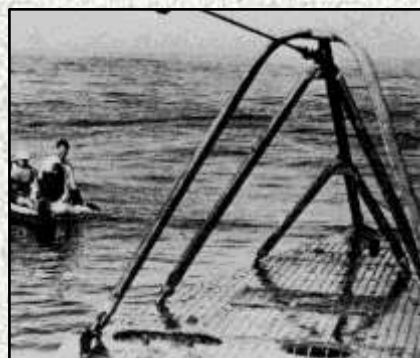
Above right (B44): Another difficulty with Revell's kit is that the attachment point for the forward jumping wire was underneath the net cutter rather than at the top. This can be clearly seen in this image of U 124 in 1941.

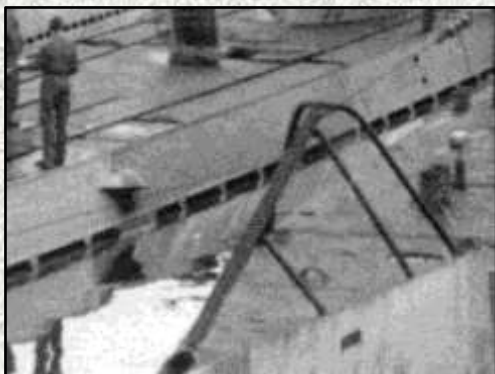
Above left (B45): The straight edge of the net cutter can be seen on the boat on the right, which is the IXA U 38.

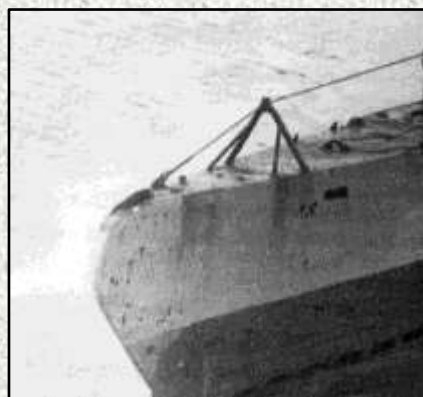
Right (B47): The inverted V on the bow of U 108 (referred to in this article as Mini).

There was also a rare feature on U 107 and U 108 in 1941 which kept the jumping wires slightly higher. On net cutters there were three inverted V support bars underneath the net cutter bar itself. On U 107 and U 108 it appears that only the farthest forward inverted V (Revell part 44) was retained, with the jumping wire joining at the top before meeting with the deck at the bow. U 108 had two further support bars ahead of the inverted V but U 107 did not.

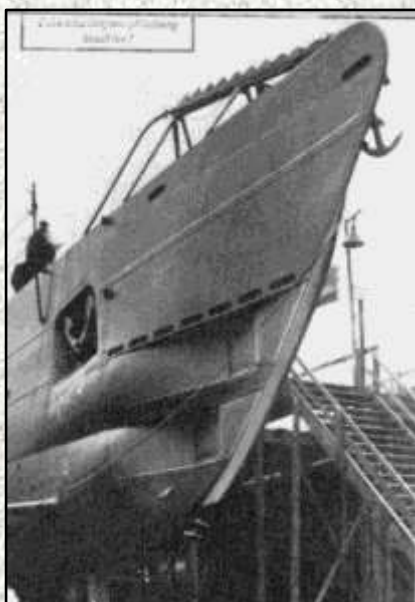
Left (B48): The large lower net cutter on the IXA U 41 in January 1939. Clearly this feature did not have a serrated edge which features in the early Revell kit.

It is likely that Revell used plan 3 within *Vom Original zum Modell: Uboottyp IXC* by Fritz Köhl and Axel Niestle for their lower net cutter (part 71). Plan 3 has the flat edge beyond a serrated edge and the jumping wire attachment point meeting with a bar behind the net cutter. This differs from the lower net cutter on U 41 which has a simple flat edge.

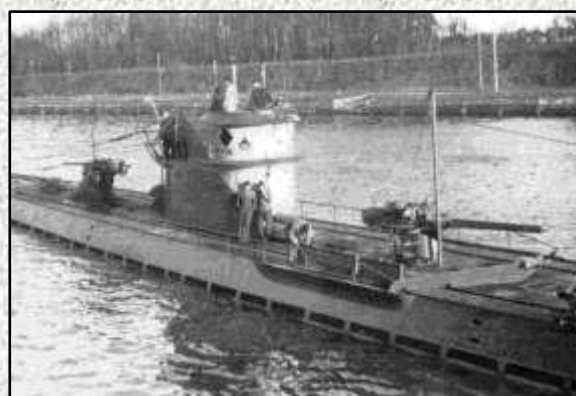
Below (B49): The second Type IXC - U 67 - on the 29th January 1941. Clearly evident are the hull breakwater on the starboard side of the hull casing and the deck breakwater ahead of the 105mm deck cannon.

One difference with the Type IXs is that there were two separate types of breakwater which were intended to help prevent waves from crashing over the crewmen operating the 105mm deck gun. The first type - referred to herein as the hull breakwaters - consisted of a breakwater fitted on

either side of the top of the hull around the area of the 105mm gun (Revell parts 82 and 83). Although the shape differed from the version fitted to the VIIIs, this first type fulfilled a similar function on the IXs by helping to prevent waves from crashing over from the sides of the hull. The second type - referred to as the deck breakwater - was the shield fitted across the deck directly ahead of the 105mm gun; this helped to reduce the water coming at the crewmen from ahead.

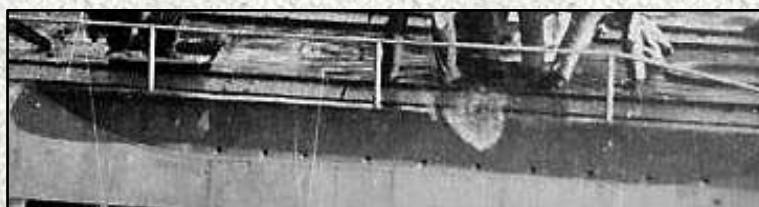
Above (B50): The hull breakwater on an IXB showing ten small round drainage holes. The third hole is not equidistant between the second and fourth hole and is slightly elevated above the rest. U 123 did have the ten holes but they were all equidistant. These holes were normally retained when the hull breakwaters were removed.

It is possible that these holes were not present on all boats with hull breakwaters. The holes cannot be seen below the breakwaters on U 106 at an unknown time, not on U 67 in January 1941, and not on U 126 and U 128 in May 1941. Nor can the drainage holes be seen on this area on U 509 in November 1942, by which time there were no hull breakwaters. The VIIBs and VIICs did not all receive the curved line of holes so there is a precedent for a lack of universal implementation. It could be that the holes are there but are difficult to discern. Modellers should be wary that these holes can be very difficult to spot due to their small size and can only be observed at short distance. If in any doubt, assume the holes were present on your chosen boat.

It is assumed that only boats which had been outfitted with the hull breakwaters would have these drainage holes. New boats launched from spring 1942 onwards would not have the hull breakwaters or these holes.

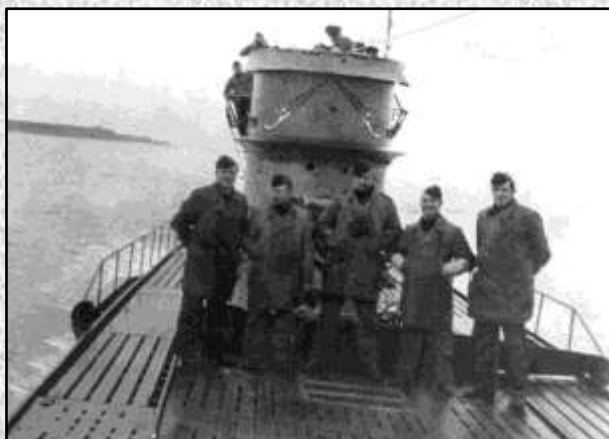
Left (B52): Here we can see U 106 with the starboard side removed. It is not clear why only one side would be left in place.

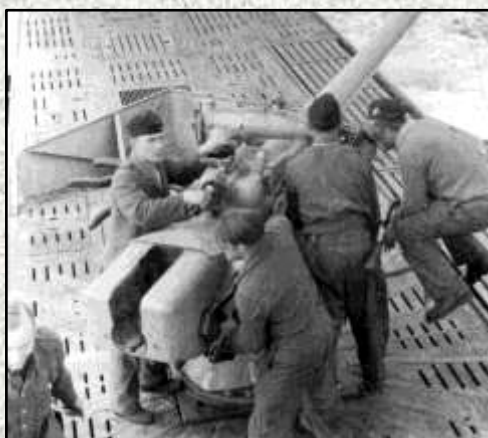
Above (B53): An unidentified Type IX with crewmen operating the 105mm deck gun. In this circumstance both the sides have been removed leaving only the central section in place.

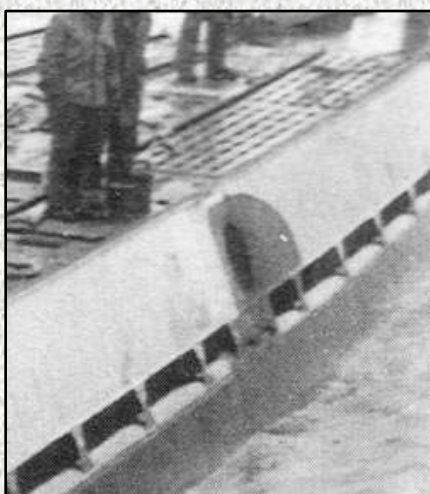
Above left (B56): The area around outlet style 2 was painted black to disguise the exhaust staining around the hole. This practice was used in the early war period but discontinued at some point.

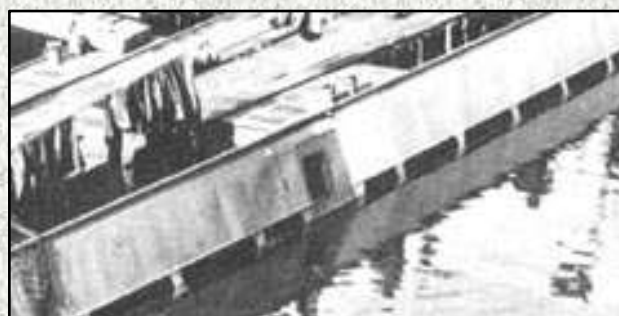
Above (B57): U 65 in Brest in September 1940 with IX outlet style 3. The two small squares are hidden by the water at the waterline. Note how the vents directly ahead and directly behind the exhaust outlet were half vents.

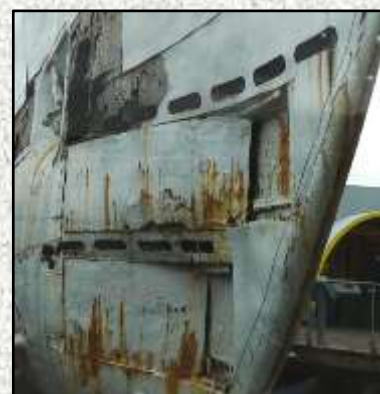
Above (B62): A somewhat damaged U 67 in October 1941. While some vents have been lost due to damage to the bow, this boat had port pattern A which was commonplace at the time.

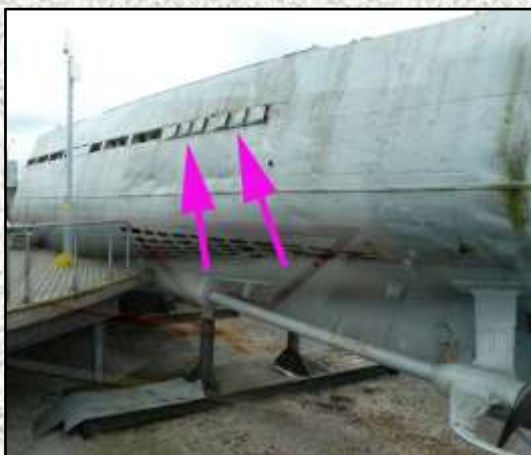
Above left (B70): The rear section of a dissected U 534 at Liverpool. Although the pole obscures this area, we can still see that the quarter-length vent (Q) is ahead of the exhaust outlet area. There is a half-length vent (H) behind where the exhaust outlet would have been. In earlier IXs there were four main vents in position P. In this photo we can see that U 534 had two main vents, with six shrouded vents (shown with the pink arrows) in place of the rear two vents in position Q.

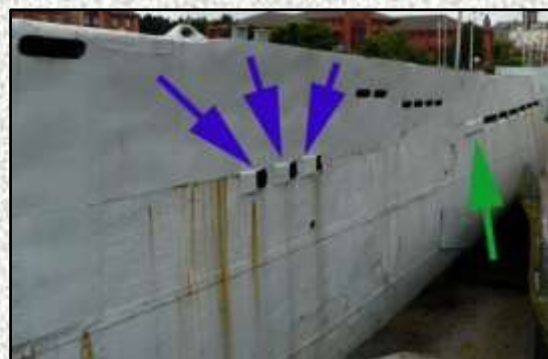
Above right (B71): The forward hull of U 534 shows two groups of shrouded vents. The blue arrows point to the three shrouded vents in position C. The green arrow points to three shrouded vents in position F. The shrouds at the front (position C) did not cover the entire vents, which was the case in positions F and Q.

Shrouded vents - A number of later IXCs had sets of small shrouded vents on the forward hull and the stern. The positions these could be found were C, F and Q. The three small shrouds in position F replaced the main vent that was the farthest forward on the main set of vents. On the bow three small shrouds were equivalent in width to one main vent. On the stern six small shrouds were equivalent in width to two main vents.

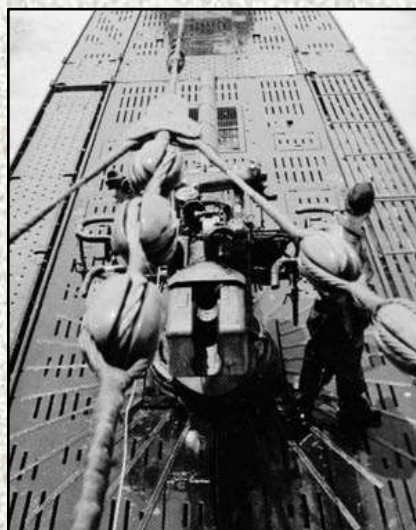
Above right (B86): A mix of styles can be seen on the IXB U 103. In channel 1 on the port side is style M and in channel 2 on the starboard side is style 7W. The braces over the top of the wooden planks make this style 7W, as opposed to 7WN which had no top braces. A torpedo container cannot be seen when looking through the gaps in the wooden planks.

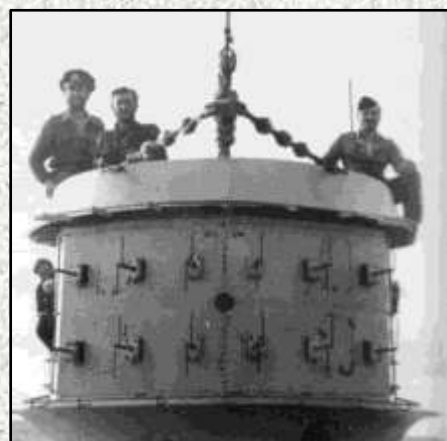
Above (B88): A frontal view showing the FuMO 29 dipoles and baseplate on an unidentified IXC.

Also known as Gema, from the firm which originally manufactured the set, this surface search radar set consisted of two rows of six dipoles fixed to a curved panel above the spray deflector. The upper row of dipoles was for transmitting and the lower row was for receiving. There were slight variations between boats but generally there was a round curved bar at the foot of the wind deflector, another curved bar fixed to the front of the top surface of the spray deflector, and a vertical bar on either side of the baseplate. The position at the front of the tower meant that it could only pick up signals from directly ahead of the boat. The sets were reported to be manufactured by firms including Gema, Siemens and Lorenz.

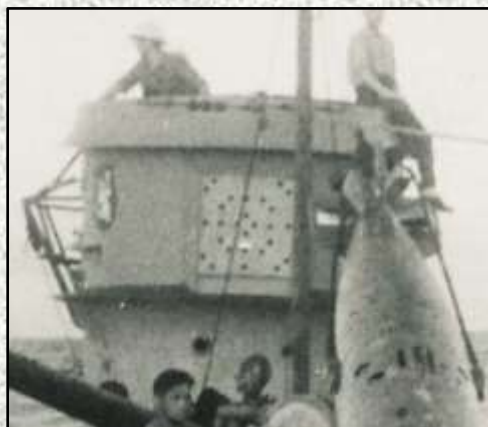
Right (B89): U 172 with *Berta* above the spray deflector.

A trials for apparatus known as *Berta* took place in late 1941. U 172 had what is presumed to be *Berta* in April 1942 during the first operational patrol. Five days into the patrol the front face was torn off due to aircraft attack. The feature was not there during the second patrol beginning in mid-May 1942. If the system had been successful we would expect other boats would have been similarly fitted but this does not appear to be the case. *Berta* is suggested to have the FuMB radar warning designation but is not listed in the radar warning codes.

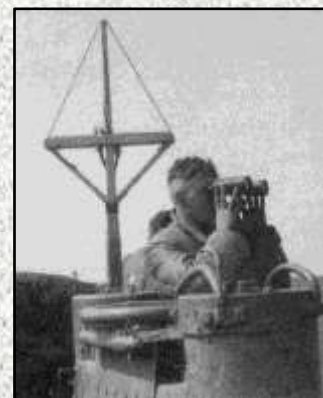
Above (B90): The diamond-shaped wood and wire Biscay cross on U 123 in March 1943.

FuMB Ant 2 Honduras antenna - The Honduras antenna (more often referred to as Biscay Cross - *Biskayakreuz* – antenna, or “Southern Cross” in interrogation reports) for the FuMB 1 *Metox* radar warning receiver was an improvised structure made of wood and wire. It was mounted on a bracket on the attack periscope base, and brought into the boat every time the boat dived. This antenna proved effective but due to its rudimentary nature and the requirement to be moved in and out of the boat, it was prone to breakage. The Biscay Cross was used on U-boats from August 1942. It was still carried on board when its replacement - *Bali (runddipol)* - was implemented in spring 1943. The Biscay Cross was still kept on board for a long time as a spare in case the *runddipol* did not function. It was no longer carried on board U 66 by January 1944.

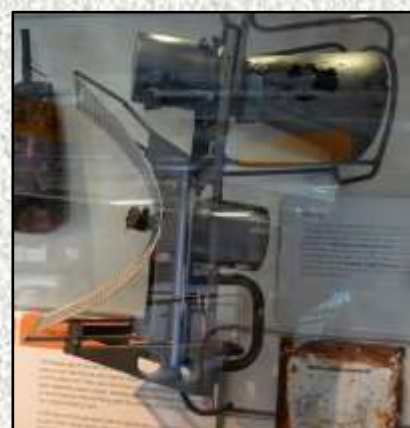
Above (B92): The FuMB 26 *Tunis* combination, which was recovered from the wreck of U 534 and is currently on display in Liverpool. The horn shape is *Mücke* and the curved shape on the other side is *Fliege*.

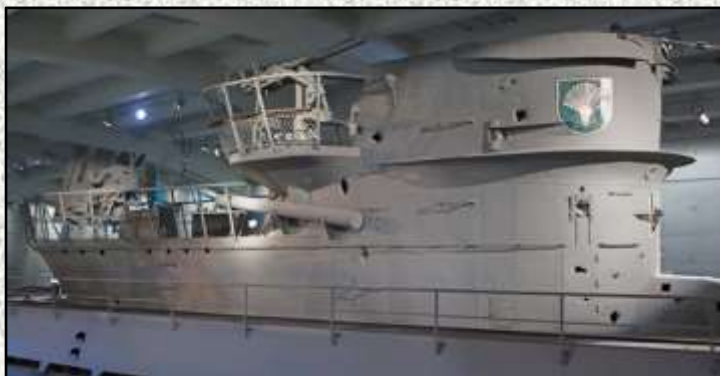
Right (B96): U 505 under cover in Chicago with a Turm IV tower which replaced the boat's Turm II.

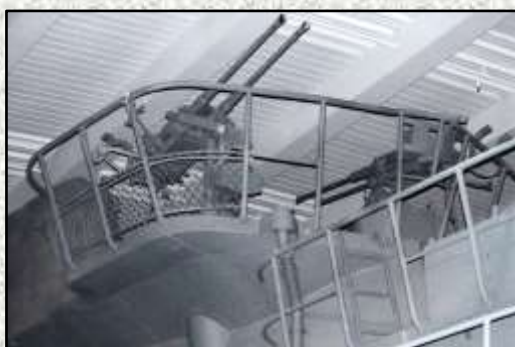
Above left (B99): The twin 20mms on the upper platform of U 505.

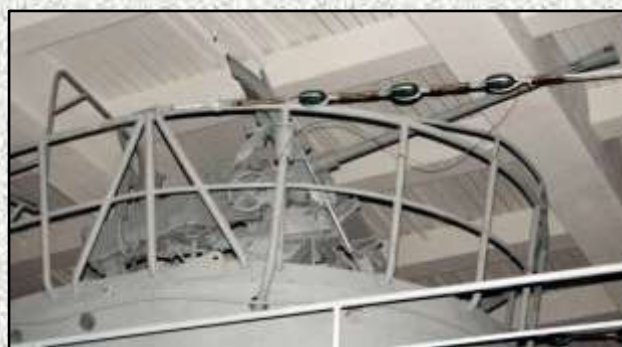
Above right (B100): The single 37mm automatic on the lower platform of U 505.

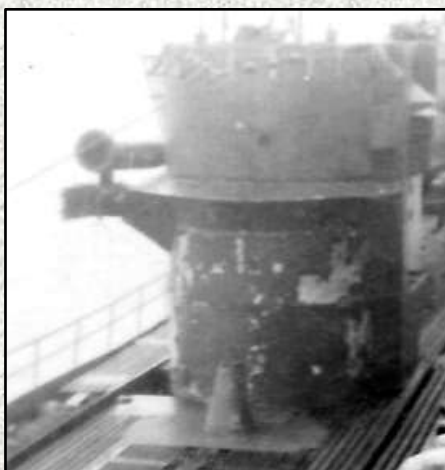
Left (B101): The metal baseplate and Askania can clearly be seen ahead of the tower on U 889.

Below (B102): A drawing of the baseplate, with the right hand side being towards the bow and the left towards the tower. The red shape is where the Askania would sit and the red rectangle is a hatch. The black holes are drainage holes.

IXCs - The situation was different on the Type IXCs where the standard magnetic compass fairing WAS removed from almost all boats and replaced with the Askania fairing. There was a gap on the real IXC decks and this was addressed with the addition of a metal base plate. This metal plate had grooves running parallel with the length of the boat. These grooves are not easy to scratchbuild by the modeller and is the sort of feature that photo-etch brass can do very well. Our proposed set 72-06 included a resin Askania but also a photo-etch base plate designed for the Revell IXC U 190 kit. However, this set was cancelled before being offered to modellers.

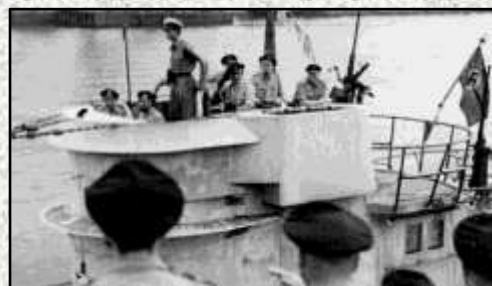
Right (B104): U 510 in August 1943 with the radar box for the FuMO 30 radar.

as some sources state, possibly late 1942. The FuMO 61 used the same box when it replaced FuMO 30. The late war boats with Turm IV such as U 805, U 853, U 861, U 862, U 866, U 875, U 889 and U 1232 had a bar running around the top of the radar box but boats such as U 190 and U 505 did not.

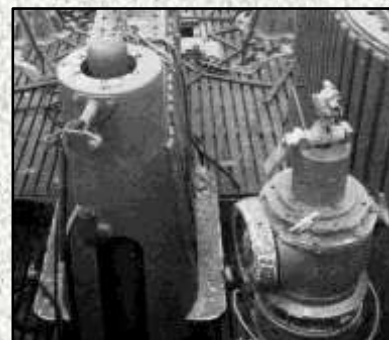
Above (B105): The newer style of UZO column was offset to port on Type IXs.

Below (B106): U 889 in May 1945, showing the newer style of direction-finding loop with a round area and aerial on top. The *Tunis* combination is mounted on a pole, with the horn-shaped *Mücke* facing away from us and the curved-shaped *Fliege* on the front.

UZO - *U*berwasserzieloptik (torpedo aimer) - In the mid-war period, the existing UZO column was replaced with a new type with a circular plate on the starboard side. U 66 had the old style in April 1943, U 537 had the new style in October 1943 and U 532 was fitted with the new style in May 1943. It would appear that the implementation occurred around the spring of 1943 but for some reason U 505 still retained the old style in May 1944.

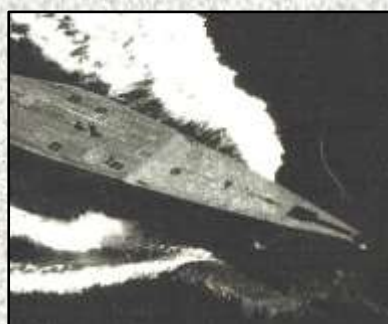
Right (B107): U 858 in 1945 with the underwater refuelling rectangle and channel on the bow. Excellent drawings and more information can be found in *An Illustrated Guide To U-Boat Research* by Simon Morris.

Underwater refueling - As a result of the loss of most of the Type XIV tankers (Milk cows), some Type VIICs, VIIC/41s and IXs were fitted with underwater refuelling by the end of the war. This consisted of a rectangular gap plus channel gap behind the top of the stem. The jumping wire attachment point was moved directly behind the rectangular gap. The IXCs U 1231, U 1233, U 1234, U 1235, as well as the VIIC U 1056, were all built with this system installed. They were commissioned between February and May 1944 but the first of these boats was launched in November 1943. It appears that the system was tested in July 1943 on a Dutch submarine, with implementation of newly-built boats beginning later in 1943. This feature was retrofitted on existing boats but this took a long period of time and some boats had yet to be fitted with the underwater refuelling by the end of the war. In May 1945 U 806, U 848, U 858, U 873 and U 883 all had this system but U 532, U 534, U 802 and U 889 did not.

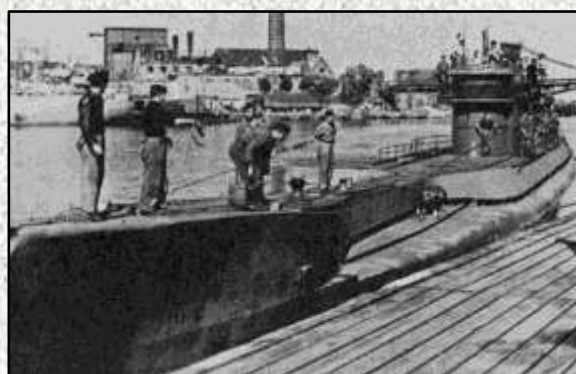
Above (B108): The IXD2/42 U 883 with a fast dive foredeck.

The test boat for this feature was U 866, with the extensive modification being completed between January and March 1944. U 866 did not have a *schnorchel* at that point, making it an unusual combination for modellers. U 539 had a different style known as style B, as opposed to the more normal style A. The fast dive foredeck modification was completed at least seven different yards so there would have been differences even within style A. Usually boats were confined to a shipyard refit for two to three months. The next completion dates are August 1944 (2), September 1944 (3), October 1944 (2), November 1944 (2), December 1944 (2), January 1945 (7), February 1945 (1) and March 1945 (1). These are the dates provided in Köhl and Niestle (with two additions by the author) and there will be others not counted here such as all the IXDs. In general the figures above provide a general idea of the completion dates. Other than the test boat U 866, we may surmise that completions began in autumn 1944 and continued throughout the winter of 1945, with a spike in completions in January 1945.
