The Wolf Pack III

A Final Collection Of U-Boat Modelling Articles

Dougie Martindale
Accurate Model Parts

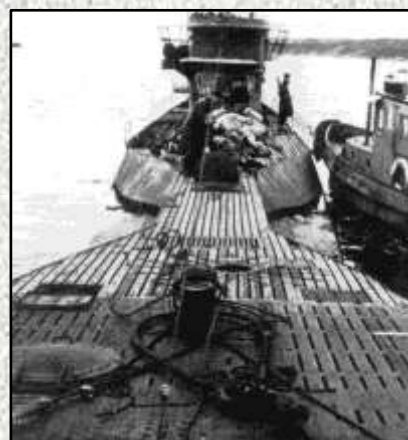
Below (B109): When the fast dive foredeck was added to the IXC/40 U 190, most of the wooden deck was replaced with the planked style that was standard at the time. Here we can see that the very front section of the foredeck was left in the old slotted deck style.

Some enthusiasts may come to believe in two fallacies - firstly, that the fast dive foredeck was an exclusive feature of the IXC/40; and secondly, that this feature was added to all IXC/40s. Although quite understandable, both these assumptions are erroneous. Many Type IXC/40s were built before the introduction of this fast dive foredeck and were therefore launched with the normal deck. It is also true that the fast dive foredeck was added to IXs regardless of variant or sub-variant.

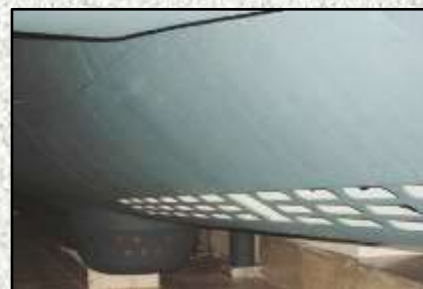
Above (B112): The underside of the bow of the museum boat U 505 showing the unpainted hydrophones arranged around the dome-shaped *Balcongerät* device.

Balcongerät - The *Balcongerät* (balcony device) was a system consisting of 48 hydrophones housing around a round dome at the bottom of the stem. It was standard on XXIs and was fitted to some VIICs, VIIC/41s, and IXs in late 1943, 1944 and 1945. U 194 was the test boat for this device which was in place on this boat by January 1943. U 66 had this device when departing on her last patrol in January 1944, with survivors from this boat stating that all Lorient boats were expected to get this at some point. This correlates with the Lorient-based U 505, which received the *Balcongerät* between January and March 1944. Fitting of this device was not universal even by the end of the war. It was not present on U 1229 in August 1944, nor was it present on U 533 and U 546 in May 1945. The *Balcongerät* was fitted to U 805 in February 1945 and was present on U 873 and U 1228 in May 1945.

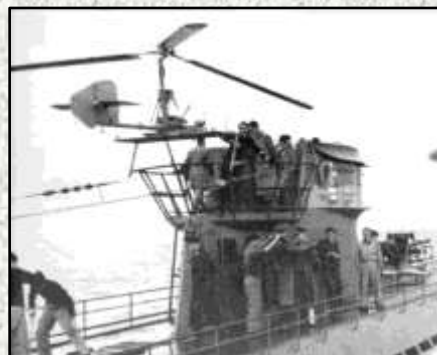
Above (B113): A Focke-Achgelis FA 330 *Bachstelze* being tested on U 532 in the autumn of 1942. The IXC has a yellow training band above the spray deflector, indicating that it had not yet been assigned to an operational flotilla.

Bachstelze - During service in the Indian Ocean, the Type IXDs carried a Focke-Achgelis FA 330 *Bachstelze* (wagtail), which was a rotary kite used for observation purposes. Capable of only vertical flight, it was tested on the IXC U 532 in August 1942. The machine was stored within two specially built pressure proof containers at the rear of the upper platform on the IXDs. The fuselage was stored in the port container and the propeller and tail was stored in the starboard container. A third container held the winch from which it was released. There was a need for the containers to remain waterproof or the *Bachstelze* would be damaged, with a spare machine stored below. The machine was released on a 492 foot long cable from a motor-driven winch within the third container and flew upwards as the U-boat sailed forward on the surface. The rotary kite flew at a height of up to 394 feet while being towed by the U-boat below. Four civilians were required to operate the kite and were on board during the lengthy operational patrols. The *Bachstelze* was fitted to U 177 and U 860 in the early months of 1943 prior to their departures in April 1944.

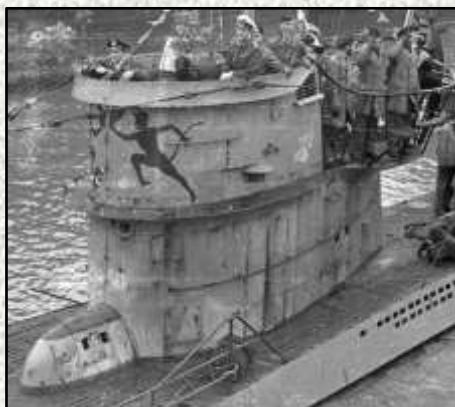
Above left (C1): The standard magnetic compass fairing on the Type VIIC U 552. As the photo illustrates, the fairing abutted the front of the tower.

The standard magnetic compass fairing was positioned at the foot of the front of the tower on all early and mid-war VIICs and IXCs. It also featured on some late-war boats and it is this type which features on the Revell kits.

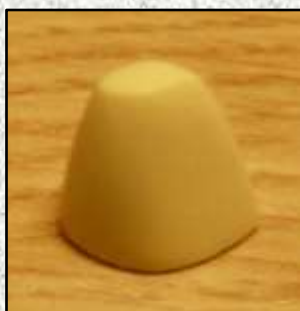
Left (C5): The resin Askania fairing by AMP. No base plate is required on VIICs and VIIC/41s.

VIIC and VIIC/41s - As discussed previously, the VIICs and VIIC/41s with the Askania fairing had this feature from the beginning. It also appears that those VIICs and VIIC/41s which had the standard fairing were not changed to the Askania type. There may have been exceptions but this means that on the VIICs and VIIC/41s there was **no need for a metal base plate** in the area directly behind and under the Askania fairing.

There exists the problem for the VIIC and VIIC/41 modeller of the gap on the deck that is exposed when they cut off the standard fairing on the Revell kit. This will not be an issue for modellers who use AMP set 72-05 as when fitting this replacement planked deck there is no gap when the Askania is fitted.

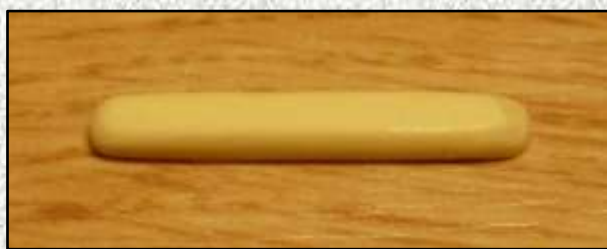
Left (C13): The resin side cushions included within Accurate Model Parts set 72-05.

The rectangles on the Revell kits are not the correct length and should be removed entirely from your model. The images in this section show the position where AMP's resin replacements should be added. The position of the side cushion on the starboard side were as follows -

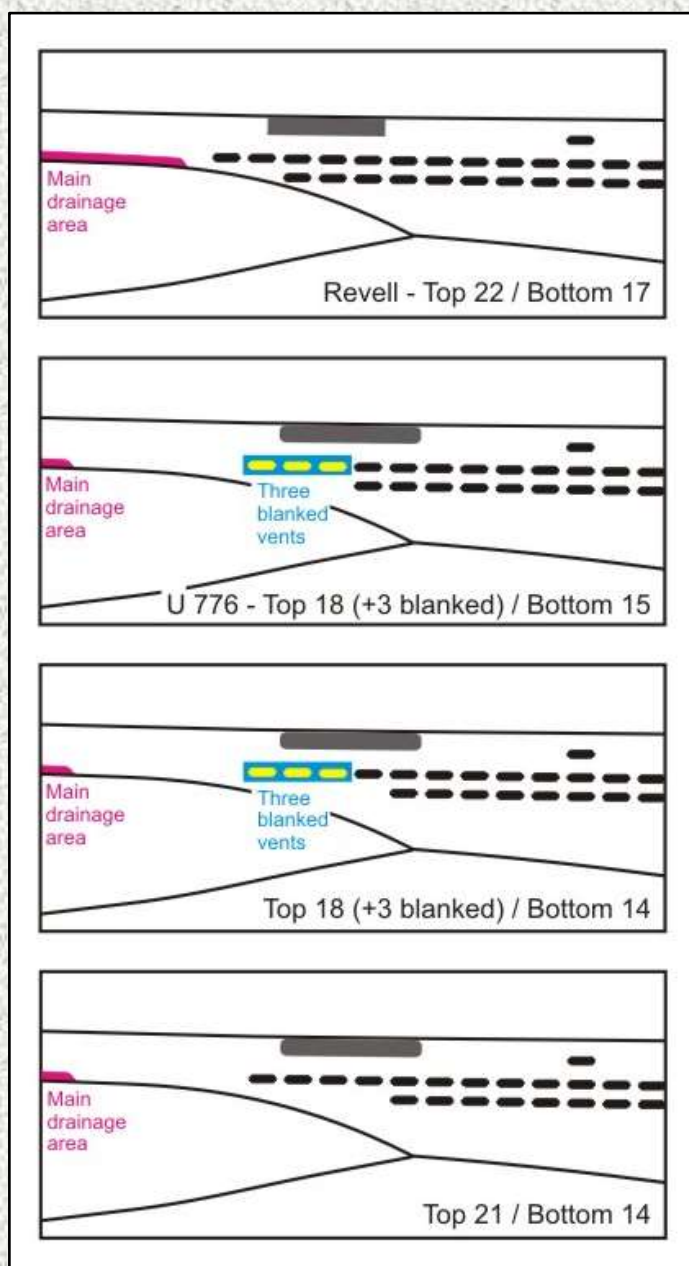
Left (C15): The drawing compares the starboard side of the Revell kit with real VIIC and VIIC/41 vent combinations. U 776 was unusual in having 15 vents on the bottom row rather than the more usual 14 vents. The vent arrangements of more VIIC and VIIC/41 boats can be found in the succeeding pages.

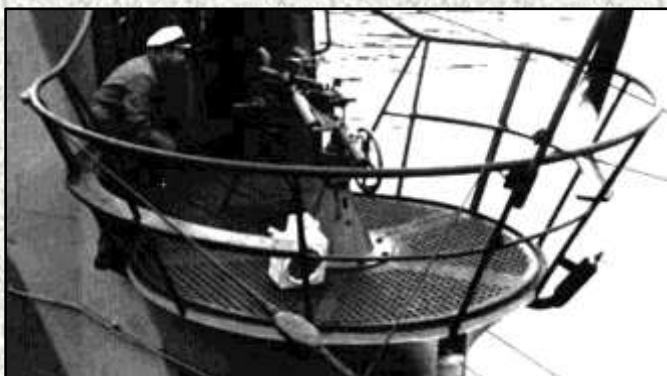
Above left (D5): The three rearmost groups can be seen in this excellent image of U 201. The boat's commander, Adalbert Schnee, is relaxing on a railing bar on the port side.

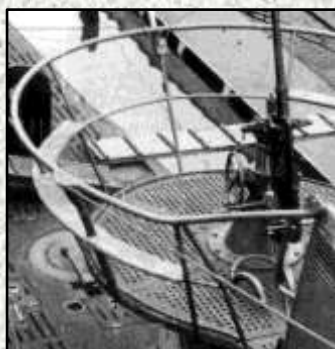
Above left (D7): Another early *Germaniawerft* boat, this time U 95, with the 20mm gun pointing to the sky.

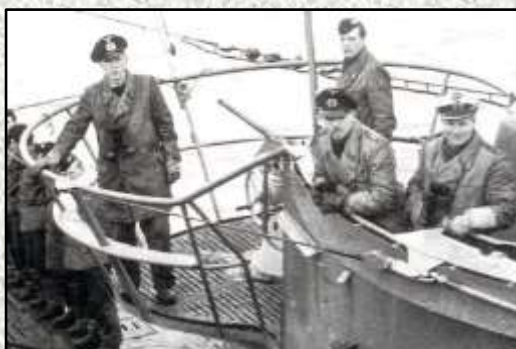
Above right (D8): Taken from the same angle, this shows U 96 with her commander Heinrich Lehmann-Willenbrock visible to the right. U 96 and U 552 remain the two most popular subjects for VIIC modellers.

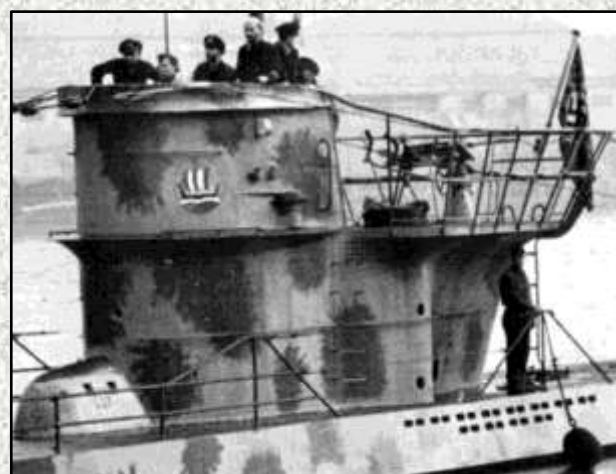
Above (D11): The VIIB U 83 with a Mittelmeerturm. Fitting AMP 72-04 and converting to this style of tower allows the modeller to choose from the camouflage schemes applied throughout this theatre of operations.

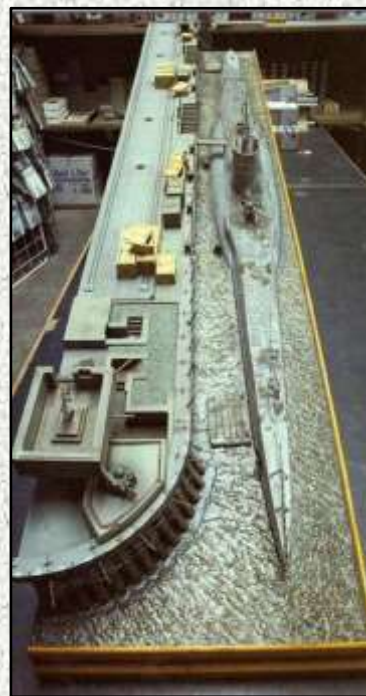
Above (E1): Within Accurate Armour's premises lies their 1/35th scale waterline Type VIIC U-boat next to their modular European Quayside kit. These are the two main kits which form the basis of The Final Return diorama. Although the conning tower can still be purchased, the final production run of the U-boat and quayside took place in late 2018.

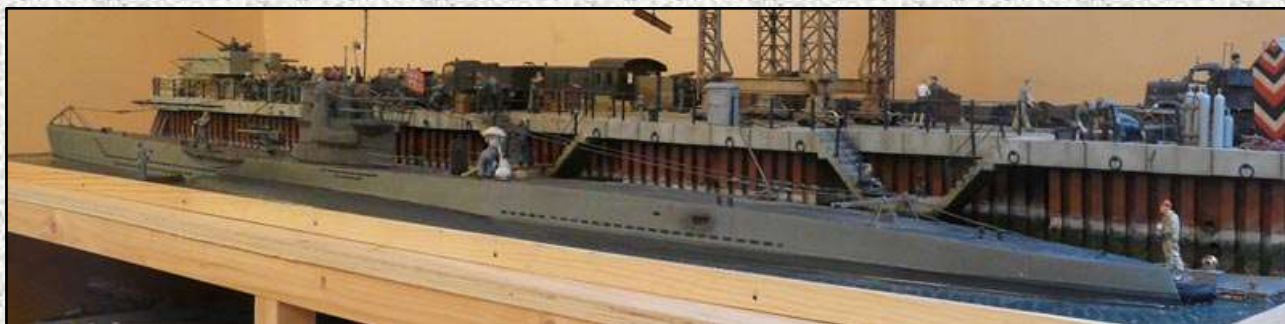
Above (E2): The completed dockside diorama of U 47 at Lorient on the 6th December 1940. Although care was taken in terms of the accuracy of the U-boat, a wide degree of artistic licence was taken in regard to the dockside diorama scene.

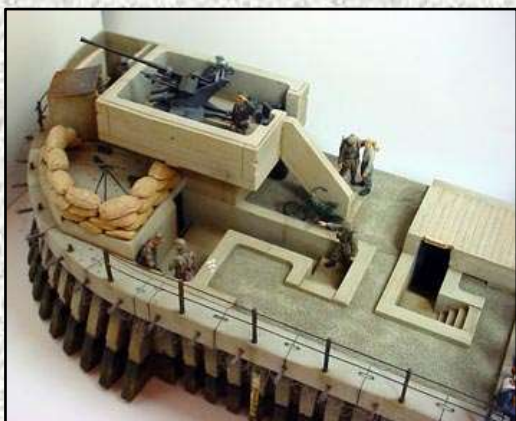
Above (E3): The left hand side of the original dockside section, as built by Julian. Compared to the final version, this area is presently devoid of colourful rubble and has no pavement section behind it.

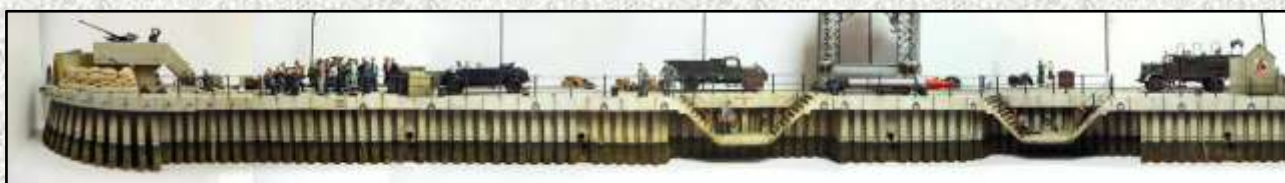
Above (E5): The most visual difference between this original version, as built by Julian, and the final version is the area above the green on the sides of the dock. This was later painted in a deep rust colour and adds colour which changes the overall look markedly. Additionally, I removed all but one of the telegraph poles. When I added a railway track section I thought that poles would be in the way of the crane when it was moving items to and from the railway trucks.

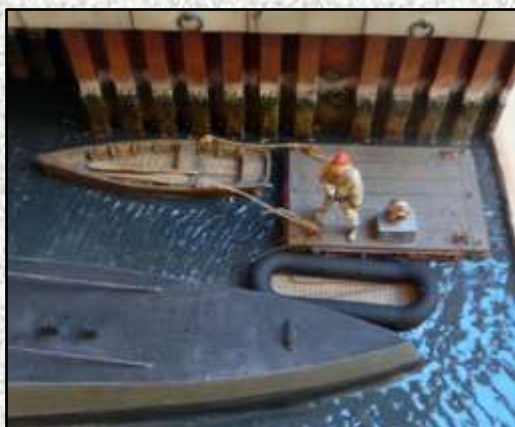
Left (E7): We start with the right hand side of the dockside. I added the wooden platform which Accurate Armour used to produce for their dockside kit. I then added the diver figure (Andrea Miniatures S5-F44), a rowboat (Verlinden 2164) and a German Rubber Raft (Bronco Models AB3578). These were the final additions to the diorama before the simulated water was added.

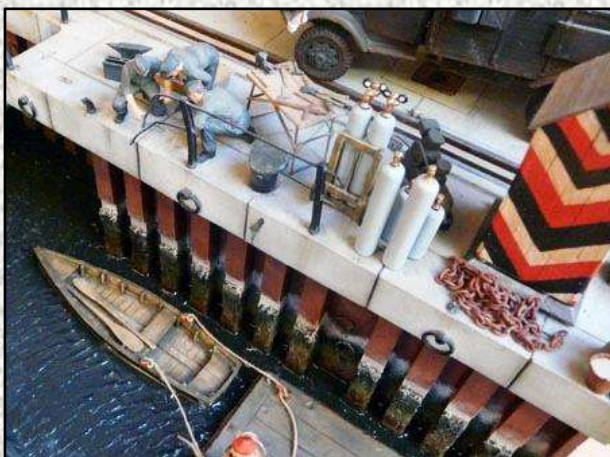
Left (E9): The bomb damage added by Julian to the right side of the dockside included broken and bent railings. I decided to add workmen (Tamiya 35180) discussing how to repair the railings. I also added a compressor, welding gear and tanks, a table with tools laid out (Tamiya 35220), an anvil and a toolbox.

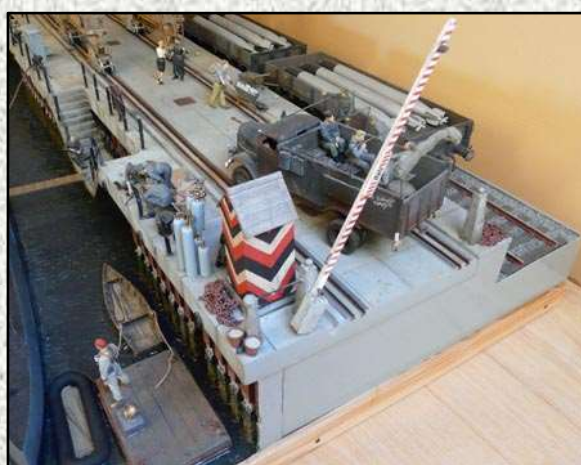
Left (E11): The bomb damage was gouged out of the resin dockside by Julian. He also added broken crane rails.

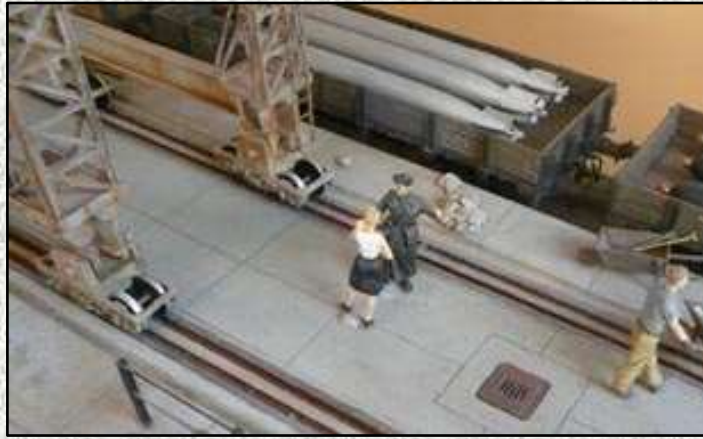
Above (E13): The worker is moving to the side to make way for the Opel Blitz truck. His pile of concrete rubble lies beyond the two other figures in this shot. One large stone is still present between the feet of the prostitute, who is busy soliciting for business. The French worker with the wheelbarrow is leaving the stone where it is as he does not want to talk to the young lady just in case he is persuaded to part with his morals and pay packet. The rust inside the crane rails, the steel colour on top of the rails, and the purple-red rust colour of the drainage panel were all repainted.

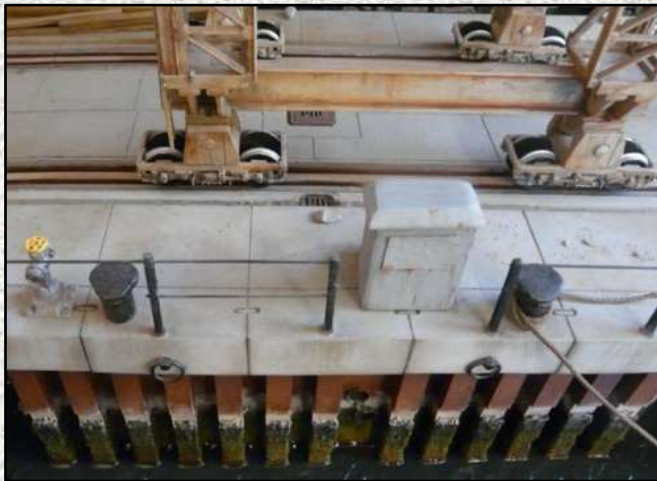
Above left (E14): A dockside requires the ability to deliver fuel, water and electrical power. On the left is a water hydrant which is part of Accurate Armour's Water / Fuel Industrial Set (D40). The middle horizontal stanchion has been removed to make way for the hosing which would be necessary to connect the hydrant to the U-boat. In the centre of this image is a scratchbuilt electrical power box. Both stanchions have been removed to make way for the electric cables. A similar hydrant, this time for fuel, is painted with a red top and is present out of shot to the left.

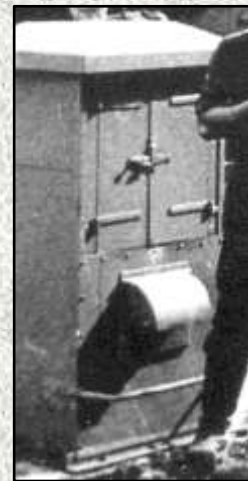
Above right (E15): The scratchbuilt electrical box was based upon this image of a real electrical box on a dockside next to a U-boat. The curved shape towards the bottom is present on the scratchbuilt box but cannot be seen as it features on the side away from the U-boat. The shape of the roof in this period image was replicated on the dockside's box.

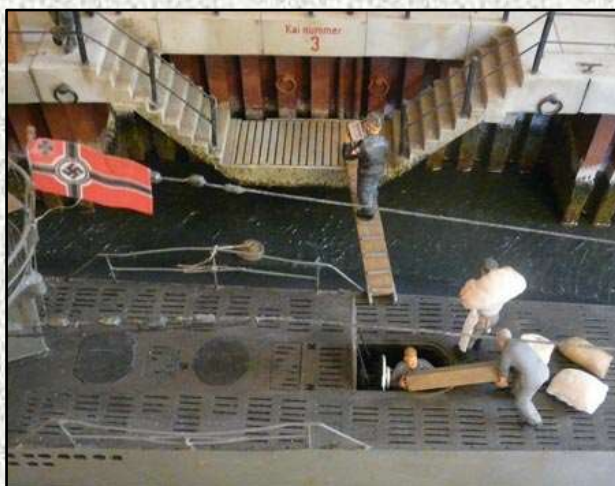
Above (E16): Julian had originally used Accurate Armour's Mooring & Gangway set (D15). When I added the U-boat I found that the aft deck railings were in the same position as the gangway. Therefore I needed a narrower gangway plank which can be seen here. Given that the U 47 patrol is complete, some supplies are being removed from the boat. All supplies had to be moved by hand in and out of the cook's hatch on the aft deck. This was a time consuming process as all supplies had to be broken down into small enough packages to fit through the hatch. The red marking "Kai nummer 3" is in genuine German typeface.

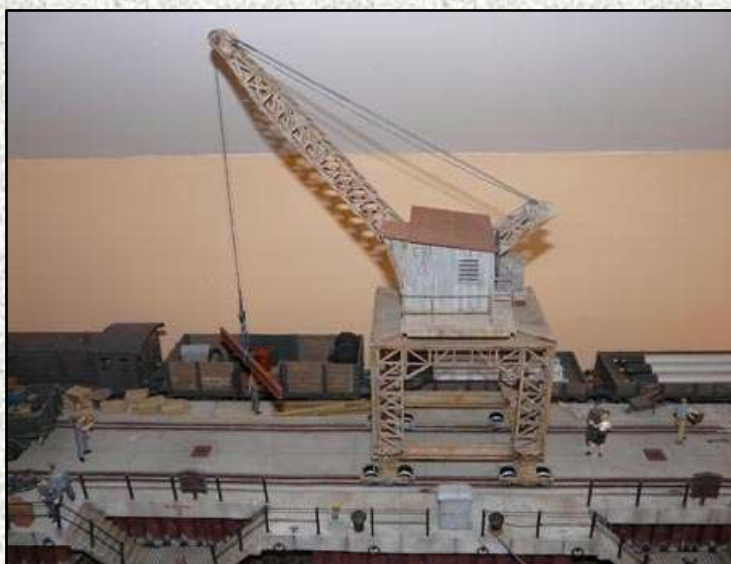
Above left (E17): Julian's scratchbuilt crane was made using railway parts.

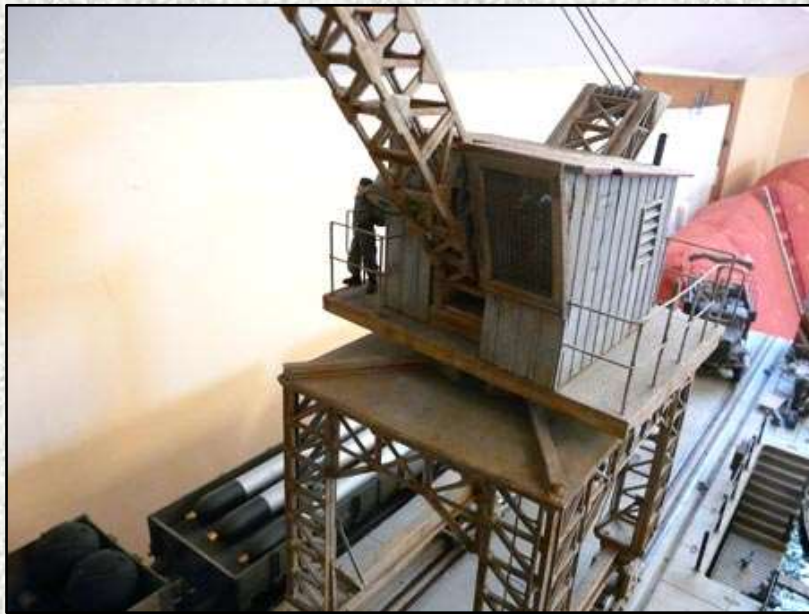
Above (E19): The interior of the crane features a diesel engine and crane operator. My own input was very limited in repainting the wheels and bogeys and adding rust.

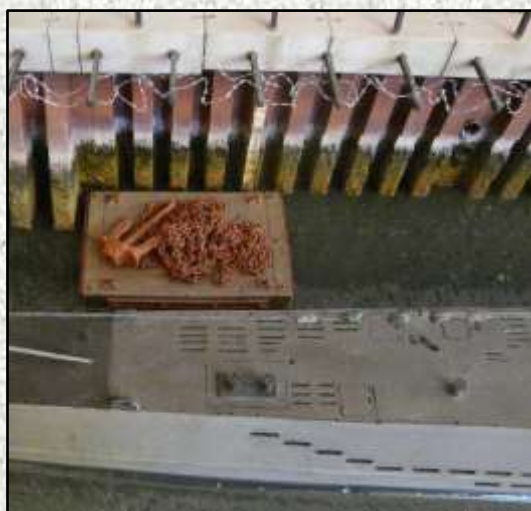
Left (E29): I kept the green colours at the bottom but added white above. Then I added various rust colours which range from red-orange to purple. This took many hours as there are 105 rectangular-shaped areas which protrude and a similar number in the background. The various colours were all dry-brushed upon an area of around seven feet to cover. It was well worth the effort as it changes the look of the dockside markedly. Note also the platform with rusty anchor and chain.

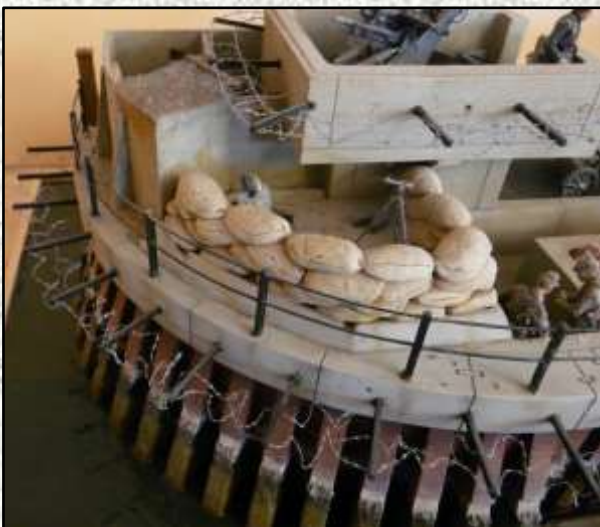
Left (E34): One of the areas damaged in transit was the barbed wire on short stanchions pointing out over this end of the dockside. I completely removed all the stanchions and added new longer versions. Then I added two rows of barbed wire plus two more rows on a similar arrangement around the main gun emplacement above. This area was previously barren.

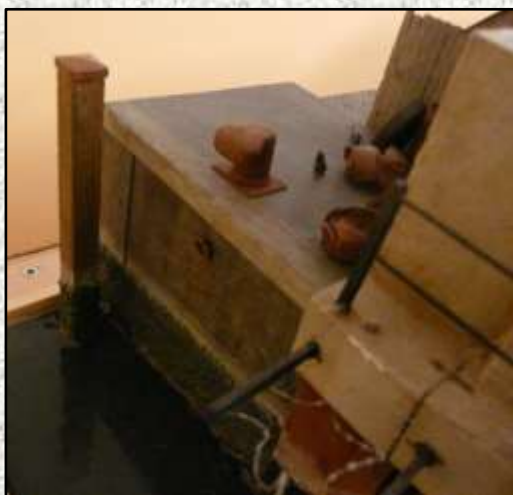
Above left (E36): When I added the railway track this added 11.5cm to the width of the dockside. This meant there would be 11.5cm extra water and some form of addition required beyond the railway buffers. To deal with this I added a pavement section using parts within Italeri's Long Dock (5612). This kit also had the walls we see here plus the wooden post. This had to match the green and white areas near the water on the rest of the dockside. Given that Julian had added extra material to bulk up the plantlife, I also had to do the same. I added granulated sugar and glued it with Humbrol plastic glue. To my surprise this seemed to work. All I had to do was carefully paint and weather this wall section.

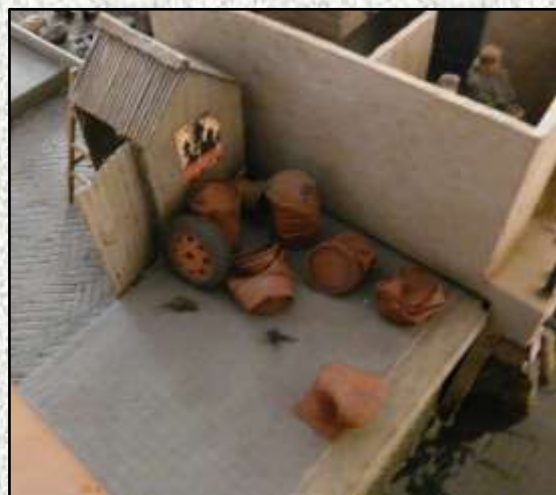
Above right (E37): I built this pavement section as a box made out of plasticard and topped it with two cobbled sections within the Italeri Long Dock. In between is a different style of pavement from a part I bought at a model show. At the end I added bashed oil drums fully rusted and a car wheel which is also rusted. Then I added two little rats, one scurrying around and another sitting up looking at me. His name is Roland.

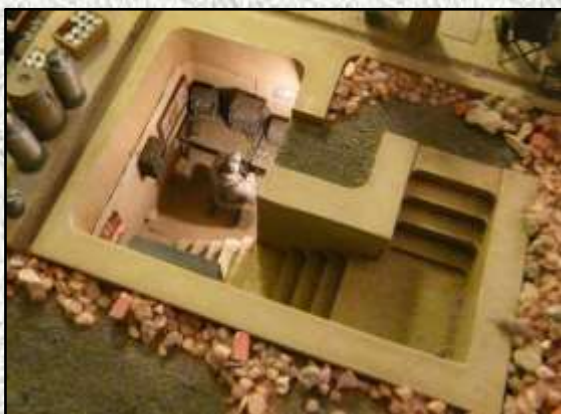
Above left (E40): A photo with the roof removed from the *Funkraum* (radio room). This was entirely built by Julian, who used the Clint Eastwood film *Where Eagles Dare* as inspiration. There are period posters on the walls and the radio operator is wearing headphones. The only additions I made were a code book plus a hardback book. The hardback book in front of him is the wartime book *Mein Weg Nach Scapa Flow* by Günther Prien, which had been released a few months ago. I sandwiched plastic between a piece of brass curved to simulate a hardback book. Then I painted it the same blue colour used on the real wartime book, a copy of which I bought years ago on Ebay.

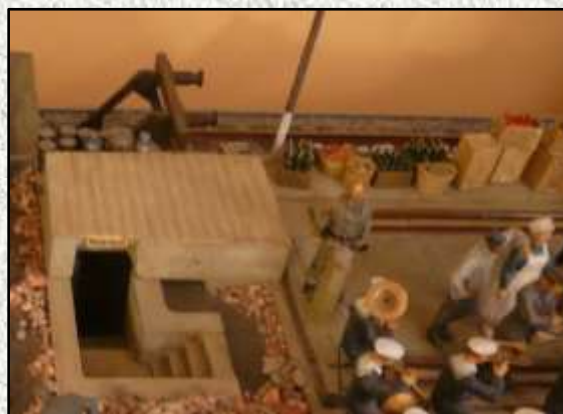
Above right (E41): The *Funkraum* with roof in place. Beyond can be seen railway buffers at the end of the track. In between are aluminium cans of various sizes.

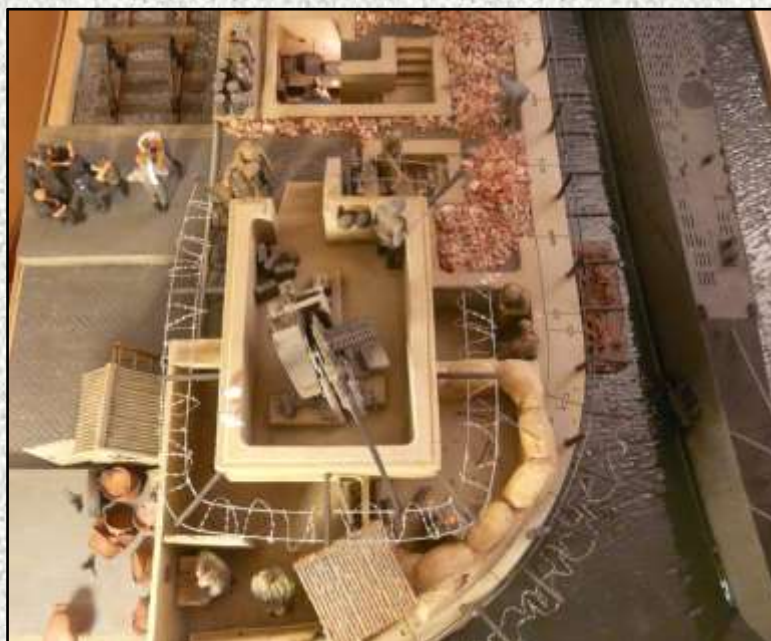
Right (E43): An overhead view showing the placement of various elements at the left side of the dockside.

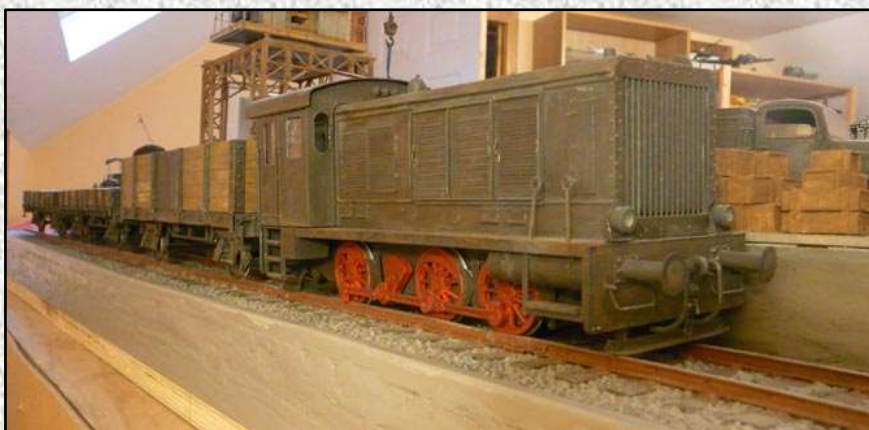
Above (E44): The Trumpeter WR 360 C12 diesel locomotive (00216) was built straight out of the box and finished in dark grey with red for the lower areas. Trumpeter Railway Gondola (high sides) (01517) was used for the truck directly behind the locomotive. All the railways items were fully weathered but this does not show up well in the images.

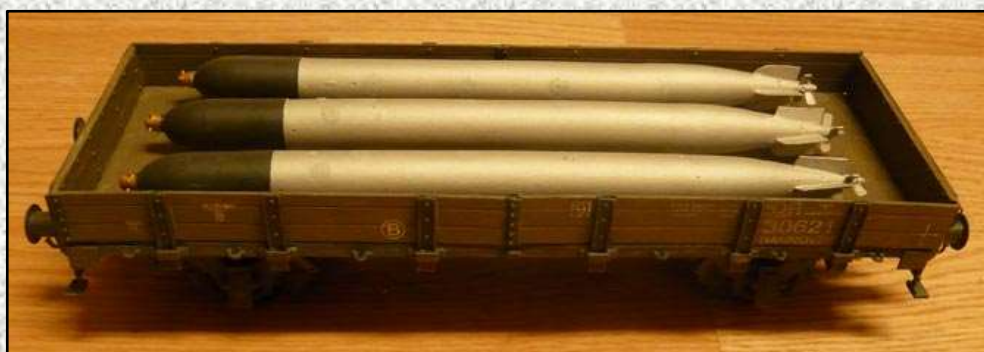
Below (E45): Trumpeter Railway Gondola (low sides) (01518) was used for the torpedoes. Two trucks were used, each carrying three torpedoes each. The torpedoes are from Accurate Armour (S03). The supports upon which the torpedoes sit were modified from the wooden transport trolleys included in the Accurate Armour kit.

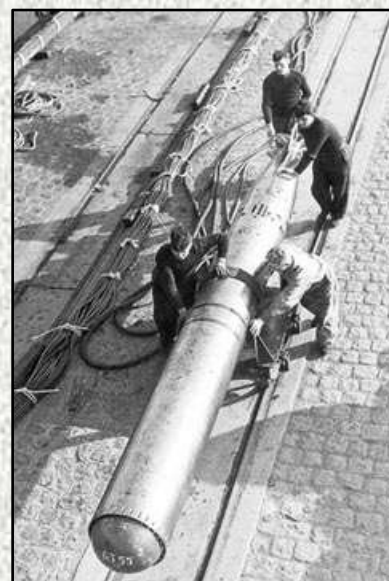
Right (E46): The Germans used wooden transport trolleys to move the torpedoes around. This is a period photo showing a torpedo on a trolley on the rails built into a dockside. This is the system in Accurate Armour's torpedo set (S03). I did plan to build trolley rails and position them in between the existing dockside and the railway section. However, with space being tight, I decided against this and had the torpedoes being able to be loaded onto U-boats directly from railway trucks. The Germans also conveyed torpedoes on the back of road trucks, with the torpedoes hanging out the back.

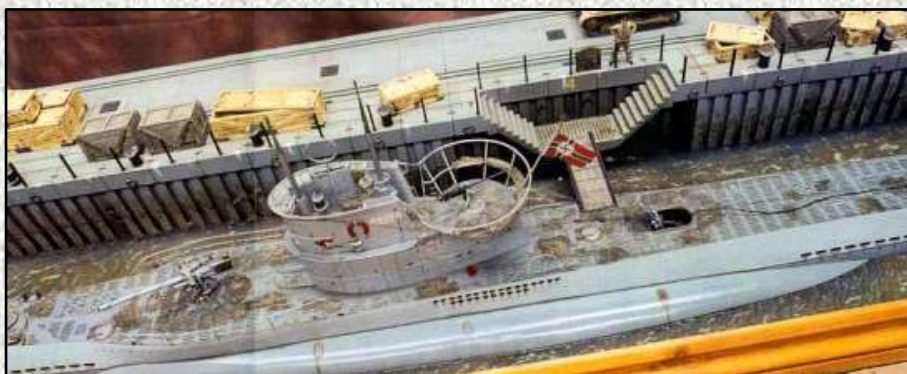
Above (E47): Again, not my model. This is the VIIC model which resides a 25-minute drive away at Accurate Armour's old premises in Port Glasgow, Scotland. The main flaw which is evident is the colour of the deck, which in this model shows brown patches through a grey colour. As we now know, the real boats were stained with a black wood preservative. The other issue is the top of the saddle tanks, which on the real boats were always painted with the dark grey anti-fouling paint rather than the lighter upper grey paint.

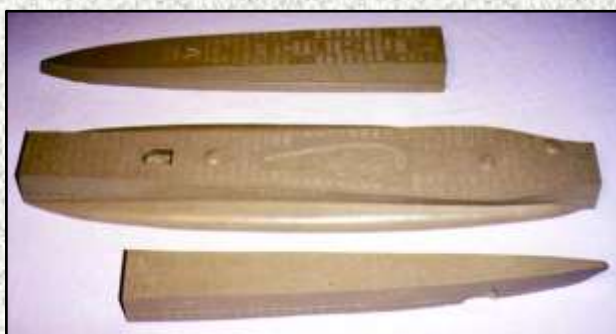
Above (E48): The three main resin pieces in Accurate Armour's VIIC kit negates the requirement to add a separate photo-etch deck. Unfortunately the slots within the resin are not crisp or perfectly aligned and may be considered as a principal flaw of the kit. The pattern of slots on the deck is also poor and requires improvement.

Free-flooding vents - The first task was to convert the VIIC pattern of free-flooding holes in the sides of the hull to that of the VIIB U 47. One identification feature between VIIBs and VIICs takes place in the hull casing just above the front of the saddle tanks. On VIIBs there were extra holes in this position. Rather than drill an extra five vents on each side, I decided to add these as parts as brass. I had previous experience of drilling U-boat vents in resin when building Amati's 1/72nd scale U 47 kit. The results were less than impressive so I now prefer to avoid drilling where possible. Correcting the vents with brass is advantageous as it results in crisp holes which are perfectly aligned.

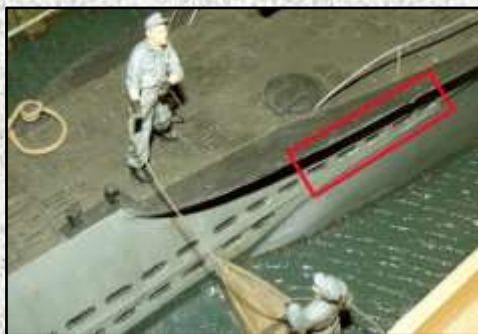
Left (E51): The area within the red box shows the extra five vents replicated using photo-etched brass. This change is essential for modelling a VIIB rather than a VIIC. The black pieces above are the breakwaters, which helped to reduce water splashing up on the crewmen operating the 88mm deck gun.

Other smaller vent corrections were made using single or double vents. Again, rather than trusting my poor ability with a drill, I preferred to correct these with the addition of brass pieces. This was not a difficult process as the resin can easily be drilled and gouged away to allow the brass parts to be fitted. In regard to the medium-sized slots in the hull casing above the saddle tanks, some were filled to fit the pattern which featured on U 47.

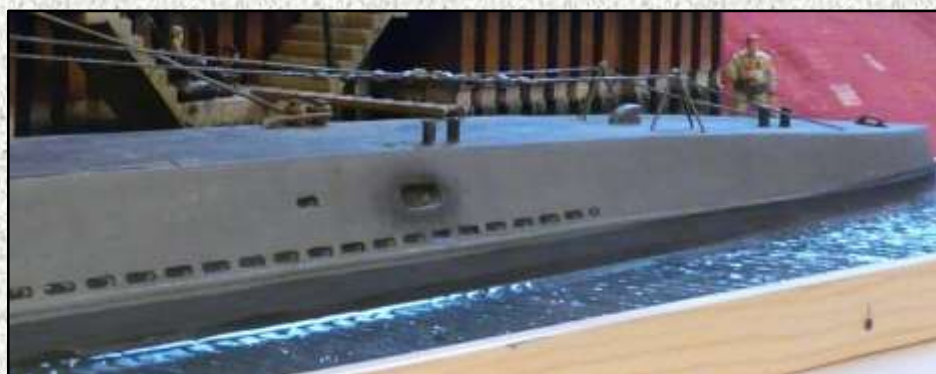
Above (E52): The main set of rear vents can be seen here. There is now an unbroken line of vents, as per U 47 in late 1940, with the large oval outlet above. The area around the outlet tended to become dirty with diesel exhaust gases, hence the weathering around the hole.

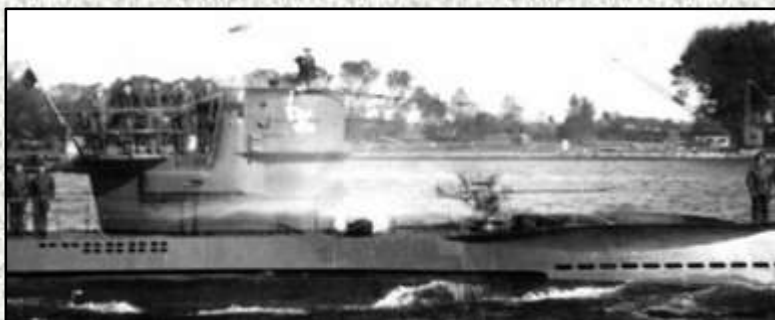
Left (E53): A side view of U 47 departing on patrol which illustrates an L-shaped air intake trunk on the starboard side of the tower. This makes a huge visual difference to the tower so care was taken to profile the resin trunks as best as possible.

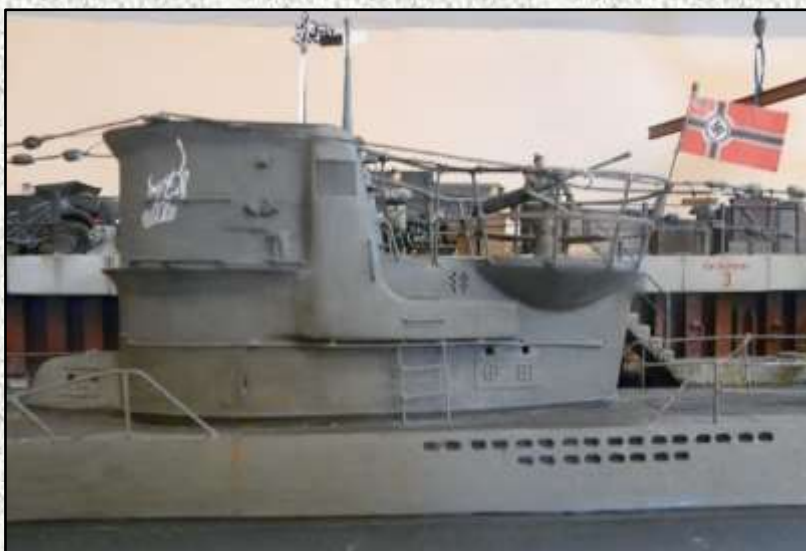
Left (E54): Here can be seen the finished model from the port side. The reshaped trunks, plate at the front of the trunk, railings, ladder and grill at the top of the trunk can all be seen. The small group of ventilation holes above the rear of the trunk were added via a part within the custom brass sheet. They could have been drilled but experience has shown that a brass part produces a much neater result.

Air trunks - As there was no standard design, slight differences existed between the L-shaped trunks fitted to the early VIIBs. The style which was unique to U 46, U 47 and U 48 had rounded edges and an intake grill positioned on the vertical sides. Using a file I began rounding the edges of Dream Arts trunks to the shape found on U 47. Then I fashioned a grill using photo-etch parts found in my spares box. I drilled away a large hole then glued the grill in place. For extra realism I added a thin piece of plasticard over the join between the front of the trunks and the tower. This was to replicate the steel sheet added in this area to improve hydrodynamics and allow water to flow better over the large trunks. I am pleased with the results of the trunks, and in particular the grill, because these make the model look specifically like U 46, U 47 and U 48 and not any other U-boat.

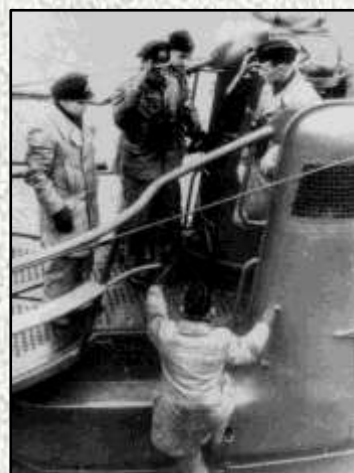
Right (E55): The commander is climbing up over the bulky external trunk on the starboard side. This required grappling with the grab bars and railings which were added to each trunk. Note how the rear of the top of the trunk is rounded whereas the top of the horizontal part has a sharp edge. The intake grill, which was replicated from brass mesh, can be seen near the top of the trunk. The coping which can be seen curving around the rear edge was also added to the model with brass rod.

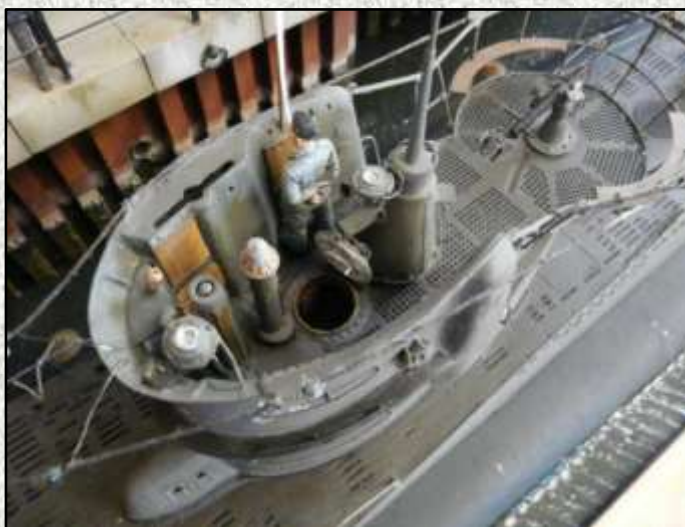
Above (E57): A view of the D/F housing, which was completely rebuilt using plasticard. The brown areas are the wooden slats (again scratchbuilt in plasticard) with wooden extendable seats below.

D/F housing - The VIIs had a housing for the direction-finding (D/F) loop) on the inside of the starboard side of the tower. The main correction required to the Dream Arts VIIB tower (and indeed for the Accurate Armour tower if that had been used) was repositioning the housing farther forward. The entire housing had to be drilled away and then a new horizontal top was scratchbuilt out of plasticard. Next the vertical walls were scratchbuilt, taking care to correctly depict get the curve at the rear.

Wooden slats - The VIIs had wooden slats added to the inside walls of the tower so that the lookouts' clothing would not stick to the steel walls in freezing temperatures. On the earliest boats there were only two slat areas on each side and this is what featured on U 47 in December 1940. I scratchbuilt each of the four slat areas and scribed vertical lines into the plastic to replicate each individual slat. There were also foldable wooden seats which were square in shape. Positioned underneath the slat areas, these were normally vertical but could be extended horizontally when in use. These were also scratchbuilt using thin plasticard. Both the slats and wooden seats were painted a wood colour and weathered.

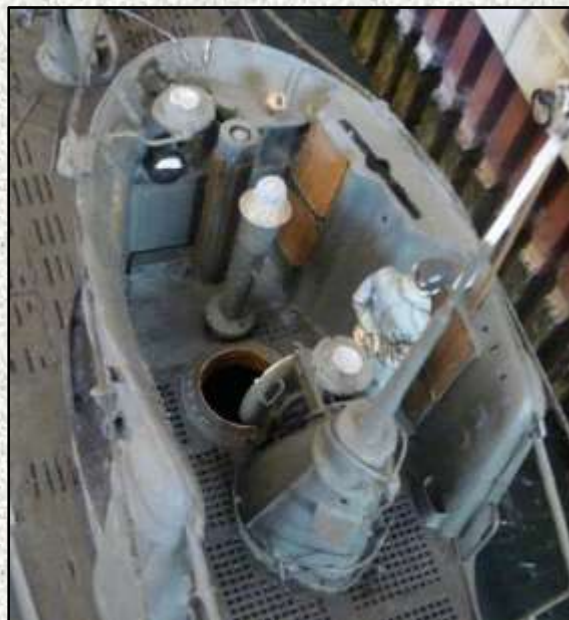
Above (E58): Many details can be discerned in this photo. The two magnetic compass repeaters - one directly in front of the attack periscope housing and the other near the front of the tower - can be seen. Below the front repeater is a cable to the boat below and a black and white dial. Over the right hand side of the "dashboard" area is a brass voicepipe on a scratchbuilt shelf.

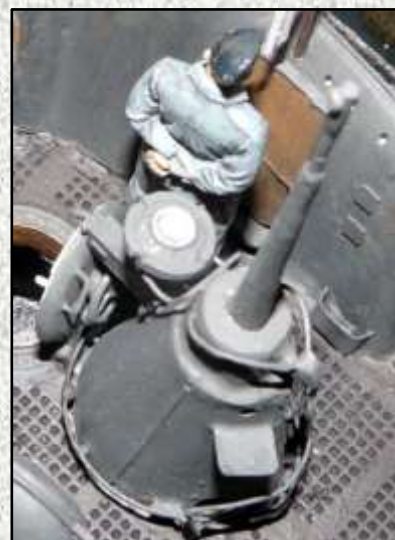
Right (E59): An eagle eye view of the attack periscope housing, clearly showing the wooden shelf in the extended position.

Attack periscope housing - The housing on the early VIIBs such as U 47 was completely different to the style found on later VIIBs such as U 99 and all the VIICs. The style on U 47 was quite a bit wider at the bottom, with the angle between the top and bottom being more pronounced. The sides were flat rather than a complex shape. This early style is not available in any kit and had to be completely scratchbuilt using plasticard. Once the basic profile was built it was filled, filed and sanded to achieve the exact features present on the early boats. Great care was taken to add the railings in brass rod in the positions they are seen in photos. The large holes near the bottom were drilled and then the semi-circular hole at the very bottom was added. The metal bars at the bottom held a horseshoe-shaped lifebelt, though in practice this was only present occasionally in the pre-war period (and not in any photos of U 47 at all). The small foldable wooden seat on offset to port was added in the extended position. The magnetic compass repeater was added in front of the housing, at the top, with a wire added below. The bendy wire around the top of where the attack periscope comes out the top of the housing was then added. This was different to that seen on VIICs so care was taken to achieve the correct shape.

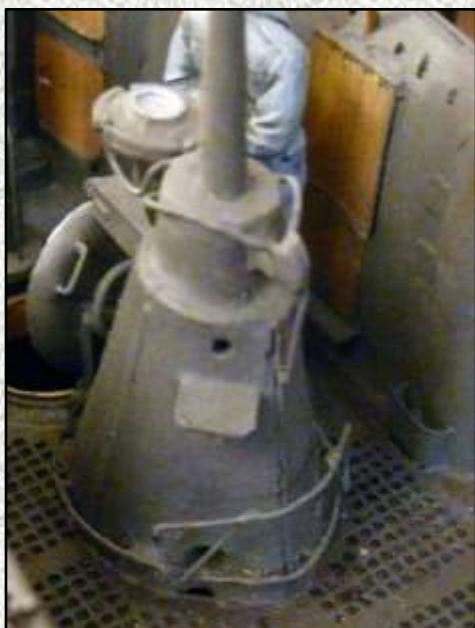
Left (E60): All the features in the photo of U 47 are replicated in the scratchbuilt housing. The bars which could be used for a lifebelt can be seen at the bottom, as well as the large hole and semi-circular hole below. The seams at the side and rear are evident here.

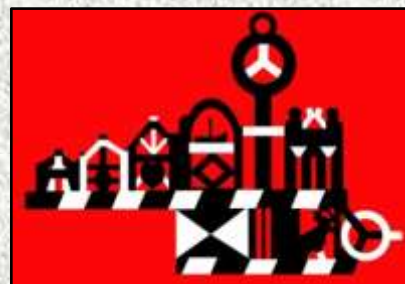
Above left (E63): The Pillkoppen pennant on the real boat. The white strip of material fluttering from the commander's flagstaff is the commissioning pennant.

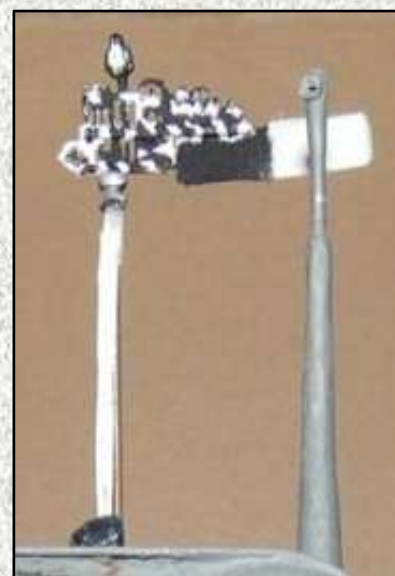
Below (E65): The brass pennant flying from the top of the commissioning flagpole on the finished model. Careful painting in black and white was required. Material used in AMP flags was used for the thin commissioning pennant and the black and white flag on the Pillkoppen pennant.

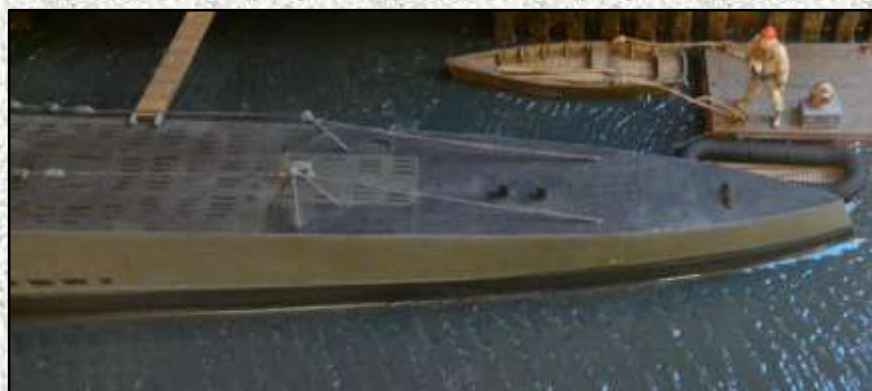
Right (E66): The rear of the model, with the rear jumping wires on top of the tripod supports. Note the difference in colour between the steel area at the stern and the wooden deck farther forward. The water surface can be seen here.

- Fairlead added beside stern.
- Tripod supports for aft jumping wire made from brass rod.
- Cook's hatch detailed, with correct holes cut out and two brass rods added.
- Two wooden poles (of 128mm and 165mm length) added at the edge of the deck.

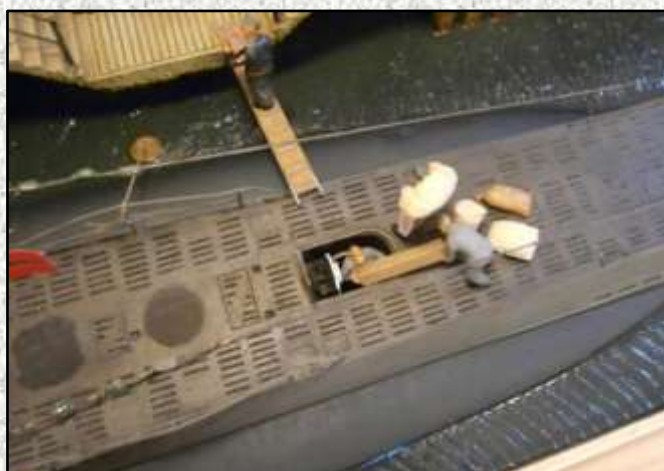
Left (E67): Supplies being delivered out of the boat by hand through the cook's hatch. The two black areas towards the left are the plates where the 20mm mount and lifebuoy had been in the pre-war period. The fender in the water can be seen suspended by rope to the aft deck railings. Only the top of the fender is required on a waterline model. I added a small brass hook at the top to tie the rope through.

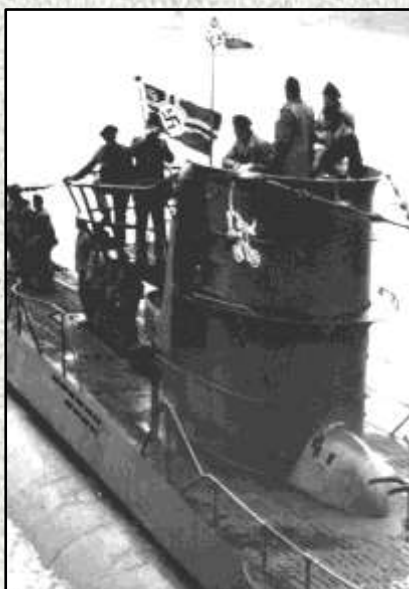
Above (E68): The deck railings on the real boat, seen here departing on the ninth patrol on the 3rd November 1940.

Aft deck railings - The aft deck railings were made from brass rod and soldered together. The style found on early VIIIBs such as U 47 were very different to that found on VIICs. The aft railings, in particular, were very different as they allowed crewmen to sit on a wooden seat on the middle bar. The wooden seat had been removed in 1940 and was therefore not added to my U 47 model. The top bar of the railings was bent outboard to allow crewmen to rest their back on the top bar.

Forward deck railings - The forward deck railings were also made from brass rod and soldered together. My own side profile drawings of U 47 were used as a reference guide to the position of the stanchion and the shape of the top rail. Note that these were significantly different to the forward railings on VIICs. Another difference is the extra two bars (plus vertical stanchion) which was fitted to U 47 in 1940. This was added to the rear of the forward deck railings.

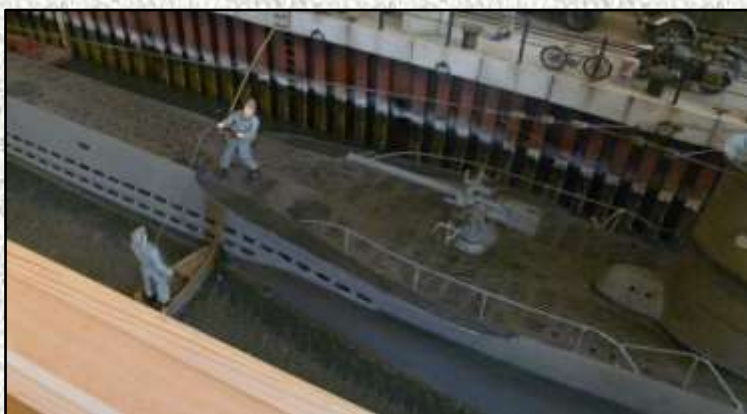
Left (E69): The black areas at either side of the forward deck are the breakwaters. The two crewmen bring an aspect of storytelling into this area of the model. Both men are holding a length of rope, the idea being that the man on the deck is about to secure the rope around the bollards of the port side of the deck. The forward section of the rowboat was scratchbuilt from plasticard.

Breakwaters - One feature which has to be added to any model of U 47 as she appeared at the end of the ninth patrol in December 1940 is the breakwaters. Also called splashguards, these were added in 1939 to the top of the hull in the area around the 88mm gun. Their purpose was to help reduce the amount of water splashing on the three crewmen operating the deck gun at sea. I designed these as part of the custom brass sheet, including the small round drainage holes along the edge. For some reason I messed this up (the Small Brain Syndrome thing was prevalent that day) and as a result they did not fit the Accurate Armour hull at all. Having discarded the brass parts I redrew them on paper. Once I had the correct shape for the horizontal surfaces I used the paper template to cut them out of plasticard. I then drilled the small drainage holes near the edges. The process was then repeated for the vertical surfaces and both were glued in place. The real boat had a smooth curve between the vertical and horizontal surfaces. I started by gluing plastic (with a cross section which was square in shape) along the underside on the edge of top of the deck. Then I added lots of filler and sanded the surface into a smooth curve. To finish I added a lip using plastic rod along the edges of each breakwater. The results were quite satisfying and well worth the effort involved.

- Wooden pole of 165mm length added to the starboard side of the deck.
- Lifebuoy plate added on the port side.
- Capstan added on the port side, including strips around.
- Three fairleads added.

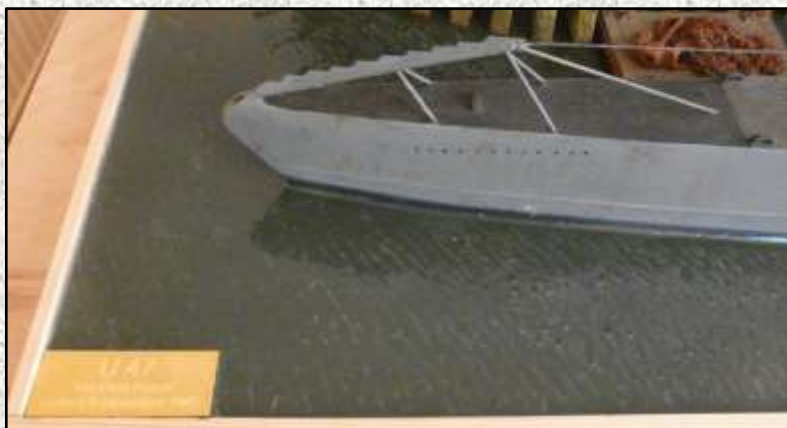
Right (E71): The scratchbuilt net cutter on the bow of the U 47 model. The water surface can be seen, as can the brass nameplate. This was part of an AMP brass sheet produced for tower floors in 2018, using spare space on the sheet.

Net cutter - The net cutter in the Accurate Armour is completely inaccurate and therefore unusable. On the kit the five white metal supports are flat surfaces (whereas the real supports were round in cross section) and there is an inaccurate number of teeth. The top part with correct number of teeth was scratchbuilt from plasticard, as was the flat piece underneath. The five supports were made with brass rod and glued at the correct angle. The entire exercise was quite easy and well worth the effort involved.
