The Wolf Pack III

A Final Collection Of U-Boat Modelling Articles

Dougie Martindale
Accurate Model Parts

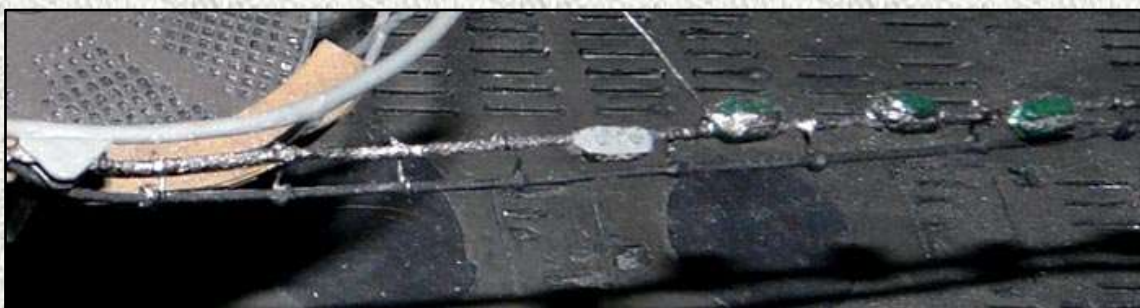
Above (E72): The extra cable can be seen on the port jumping wire of the completed model, as can the bottle green insulators.

U 47 featured an extra cable on the port side of the rear jumping wire. This feature was only present on the earliest *Germaniawerft* boats produced in that shipyard; this included the early VIIBs such as U 47 and U 99 as well as the very earliest VIICs in the batch U 93 to U 98. This additional cable was added using thin metal rod, with a number of connecting wires securing it to the port jumping wire.

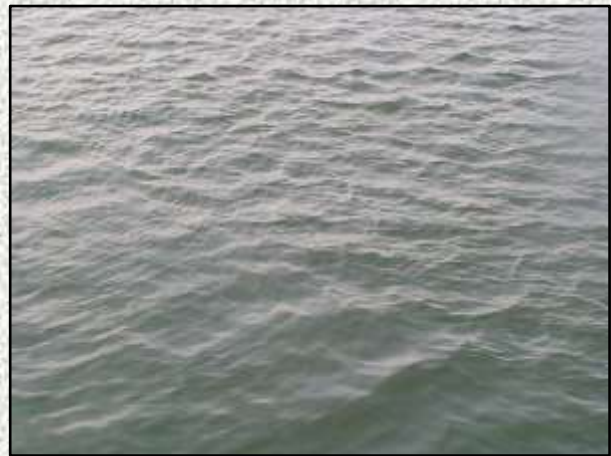
Above (E73): I took photos of water to study the ripples in the water under various wind conditions. I also studied the colour, which often looks more of a very dark grey than blue.

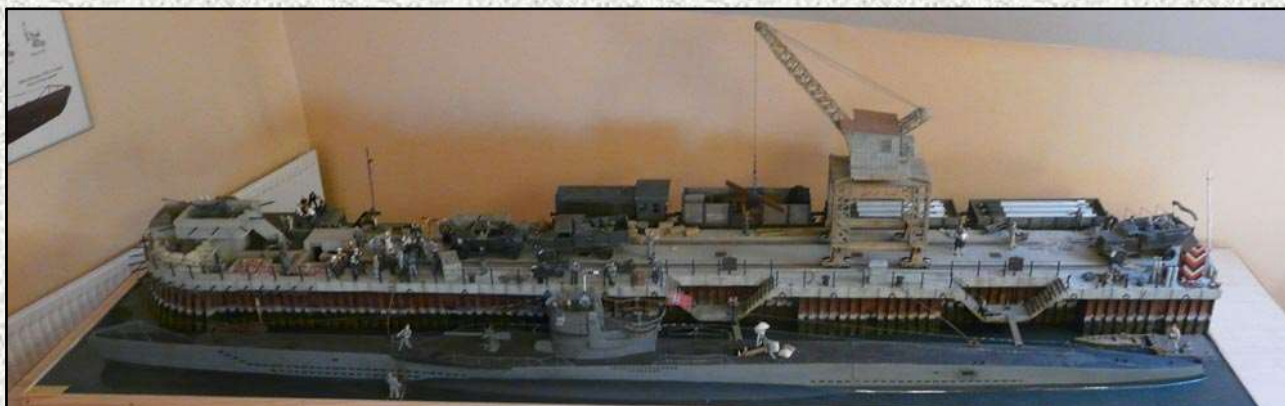
Above (E75): The dockside and U-boat when completed in late 2018.

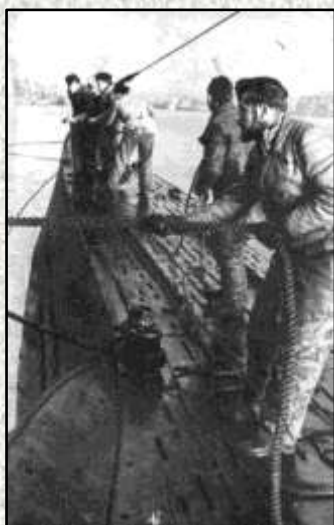
Left (E79): The bearded crewman, who has not shaved when U 47 has been at sea for just over a month, is pulling a thick rope and is preparing to wrap it around one of the bollards. Note how the port breakwater seems canted up at an angle.

From some angles the breakwaters look to be angled upwards but in other photos they look flat. I have not found as yet found the answer to this riddle.
